# EXISTING AGRICULTURAL DRAIN TILE INVESTIGATION PLAN

## SV CSG Welter Road Solar LLC

Prepared for: Sunvest Solar LLC

Section no. 15, Virgil Twp., Kane Co., IL

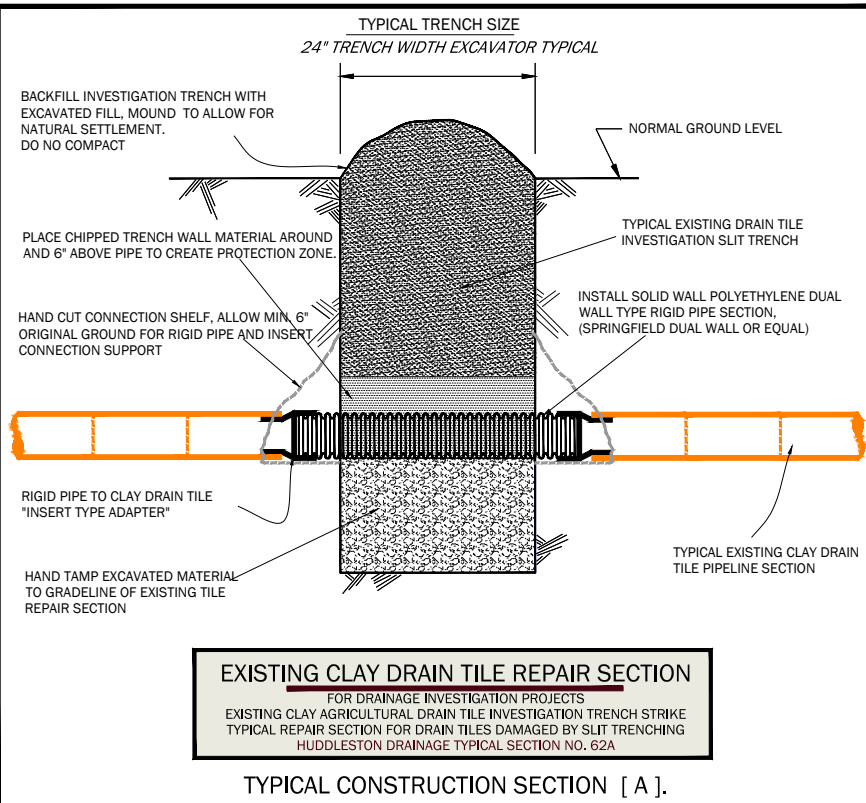
| ID NO. | SZ. | TYPE / QUALITY | FLOW % | SILT % | DEPTH<br>GRID/IN. | FIELD NOTES: |
| A | — | NO DRAIN TILES | — | — | — | NO DRAIN TILE LOCATED |
| B1 | 4" | CLAY / GOOD | SLIGHT | 25% | 30" | SILT RESTRICTED / PARTIAL CAPACITY |
| B2 | 4" | CLAY / GOOD | SLIGHT | 50% | 38" | SILT RESTRICTED / PARTIAL CAPACITY |
| B3 | 4" | CLAY / FAIR | SLIGHT | 70% | 24" | SILT RESTRICTED / PARTIAL CAPACITY |
| C1 | 4" | CLAY / GOOD | SLIGHT | — | 24" | ACTIVE FLOW RATE AND CAPACITY |
| C2 | 4" | CLAY / GOOD | SLIGHT | FULL | 22" | SILT RESTRICTED / NO CAPACITY |
| C3 | 4" | CLAY / GOOD | SLIGHT | — | 34" | ACTIVE FLOW RATE AND CAPACITY |
| E1 | 4" | CLAY / GOOD | SLIGHT | 22% | 22" | ACTIVE FLOW RATE AND CAPACITY |
| E2 | 4" | CLAY / GOOD | SLIGHT | — | 28" | ACTIVE FLOW RATE AND CAPACITY |
| F2 | 3" | CLAY / GOOD | SLIGHT | 25% | 22" | SILT RESTRICTED / PARTIAL CAPACITY |
| H | — | NO DRAIN TILES | — | — | — | NO DRAIN TILE LOCATED |
| H1 | 4" | CLAY / GOOD | SLIGHT | 30" | 30" | ACTIVE FLOW RATE AND CAPACITY |
| H2 | 4" | CLAY / GOOD | SLIGHT | 20" | 20" | ACTIVE FLOW RATE AND CAPACITY |
| H3 | 10" | CLAY / POOR | SLIGHT | FULL | 24" | SILT RESTRICTED / NO CAPACITY |
| I2 | 10" | CONC. / GOOD | 75% | SLIGHT | 40" | ACTIVE FLOW RATE AND CAPACITY |
| K1 | 4" | CLAY / FAIR | SLIGHT | SLIGHT | 23" | ACTIVE FLOW RATE AND CAPACITY |
| K2 | 4" | CLAY / FAIR | SLIGHT | SLIGHT | 28" | ACTIVE FLOW RATE AND CAPACITY |
| L | — | NO DRAIN TILES | — | — | — | NO DRAIN TILE LOCATED |
| N1 | 6" | CLAY / GOOD | FLOODED | 50% | 39" | RESTRICTED FLOW AND SURCHARGED |
| O | — | NO DRAIN TILES | — | — | — | NO DRAIN TILE LOCATED |
| P1 | 3" | CLAY / GOOD | SLIGHT | SLIGHT | 28" | ACTIVE FLOW RATE AND CAPACITY |
| P2 | 4" | CLAY / GOOD | SLIGHT | SLIGHT | 28" | ACTIVE FLOW RATE AND CAPACITY |
| R1 | 4" | CLAY / GOOD | SLIGHT | SLIGHT | 28" | ACTIVE FLOW RATE AND CAPACITY |
| S | — | NO DRAIN TILES | — | — | — | NO DRAIN TILE LOCATED |
| V | — | NO DRAIN TILES | — | — | — | NO DRAIN TILE LOCATED |

- Solar Field Development: It is our recommendation that all existing drain tile systems within the proposed solar field development should be replaced by "like kind" construction which will assure the location and replacement of unknown drain tile systems that were not located by this Existing Drain Tile Investigation.
