Wetland Delineation Report

Big Timber & Reinking Roads Site

Town of Rutland, Kane County, Illinois December 13, 2024

Project Number: 20241389

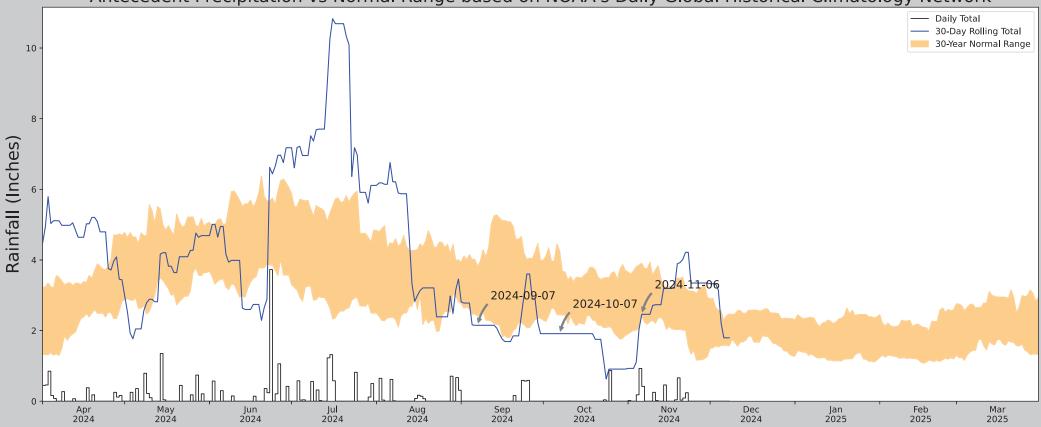
Antecedent Precipitation vs Normal Range based on NOAA's Daily Global Historical Climatology Network

Coordinates	42.1081410, -88.4572961
Observation Date	2024-11-06
Elevation (ft)	914.337
Drought Index (PDSI)	Mild drought
WebWIMP H ₂ O Balance	Wet Season

30 Days Ending	30 th %ile (in)	70 th %ile (in)	Observed (in)	Wetness Condition	Condition Value	Month Weight	Product
2024-11-06	2.41063	3.908268	2,46063	Normal	2	3	6
2024-10-07	2.449606	4.259055	1.913386	Dry	1	2	2
2024-09-07	2.409055	3.819291	2.149606	Dry	1	1	1
Result							Drier than Normal - 9

According to the APT analysis using the previous 90 days of precipitation data, conditions encountered at the time of the November 6, 2024 fieldwork were expected to be drier than normal for the time of year (Appendix B). The Palmer Drought Severity Index was checked as part of the APT analysis, and the long-term conditions at the time of the fieldwork were in the mild drought range. Fieldwork was completed outside the dry season based on long-term regional hydrology data utilized in the WebWIMP Climatic Water Balance and computed as part of the APT analysis.

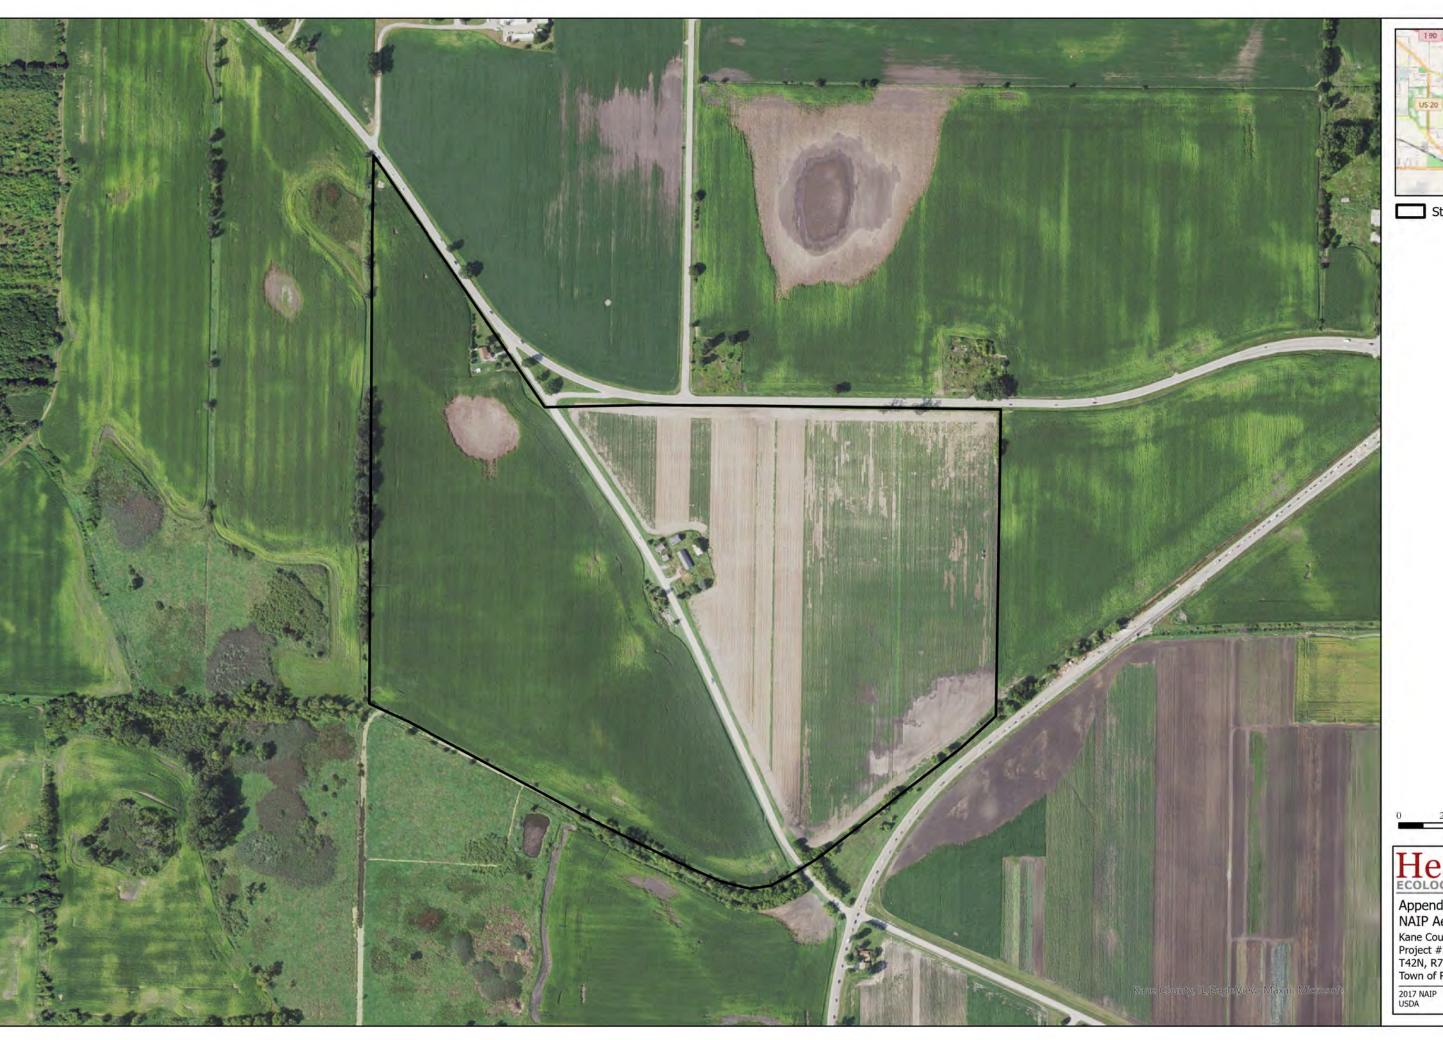
Appendix: 2017-09-01 NAIP Aerial Imagery Kane County 107.87-Acre Site Project #20241389 T42N, R7E, S18, S19, S20 Town of Rutland, Kane Co, IL

Study Area (108.64 ac)

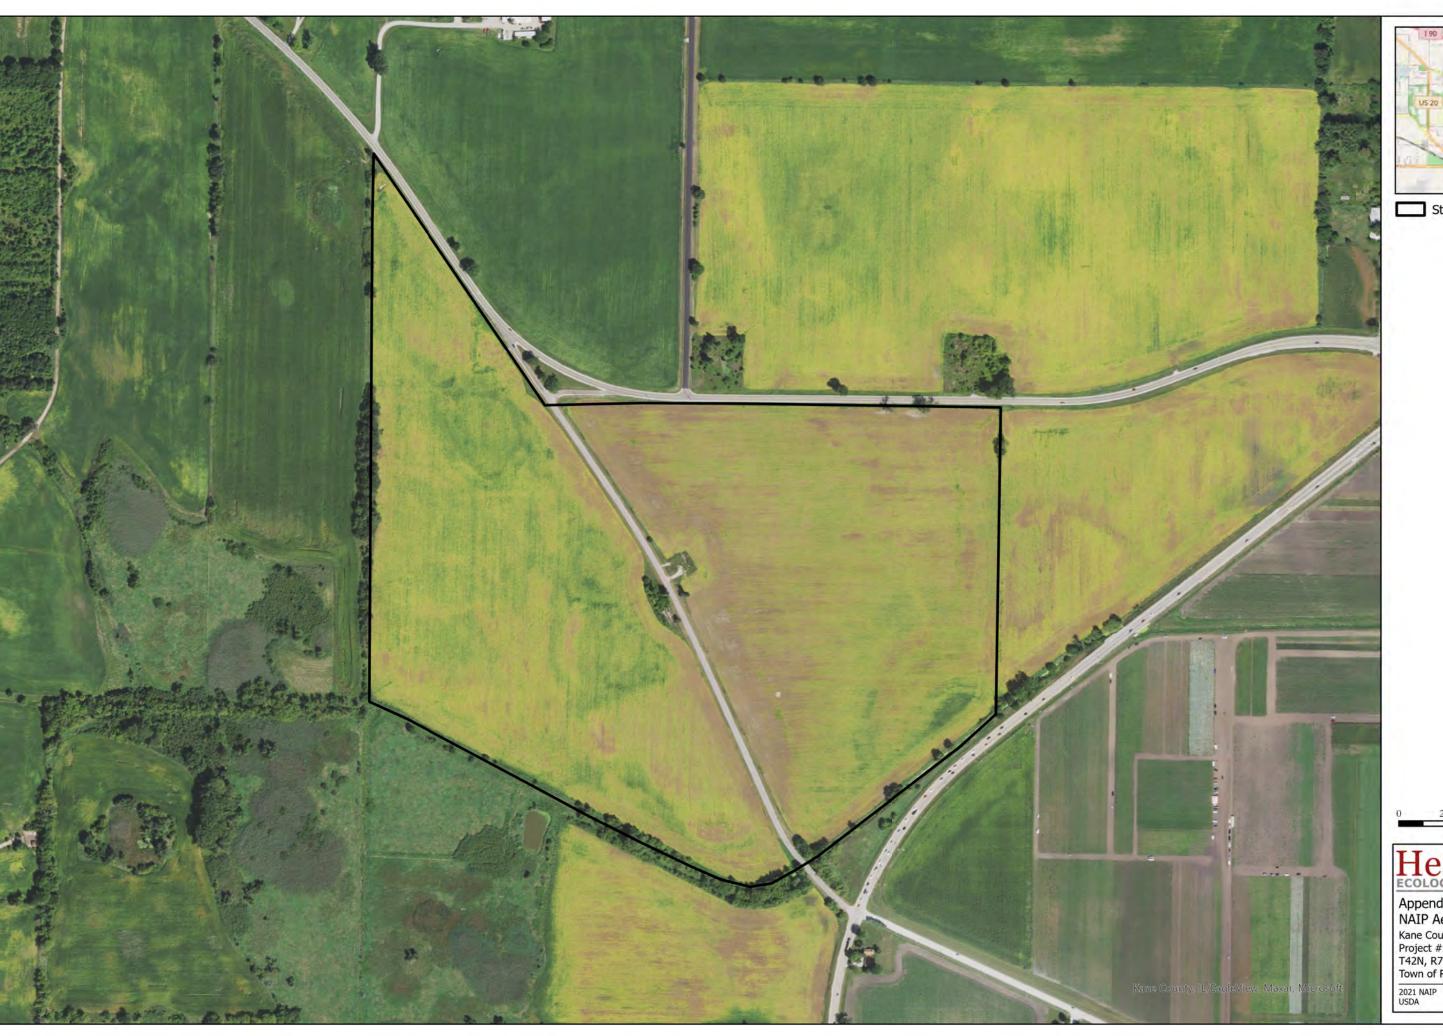
Appendix: 2021-09-05 NAIP Aerial Imagery Kane County 107.87-Acre Site Project #20241389 T42N, R7E, S18, S19, S20 Town of Rutland, Kane Co, IL

Study Area (108.64 ac)
