U.S. Army Corps of Engineers – Chicago District

Area M Consulting (Area M), on behalf of SV CSG Sun Trust Solar, LLC, conducted a field wetland delineation within the proposed SV CSG Sun Trust Solar, LLC solar project (Project) located near Gilberts, IL in Kane County.

Wetland Delineation Report
SV CSG Sun Trust Solar, LLC
Kane County, Illinois

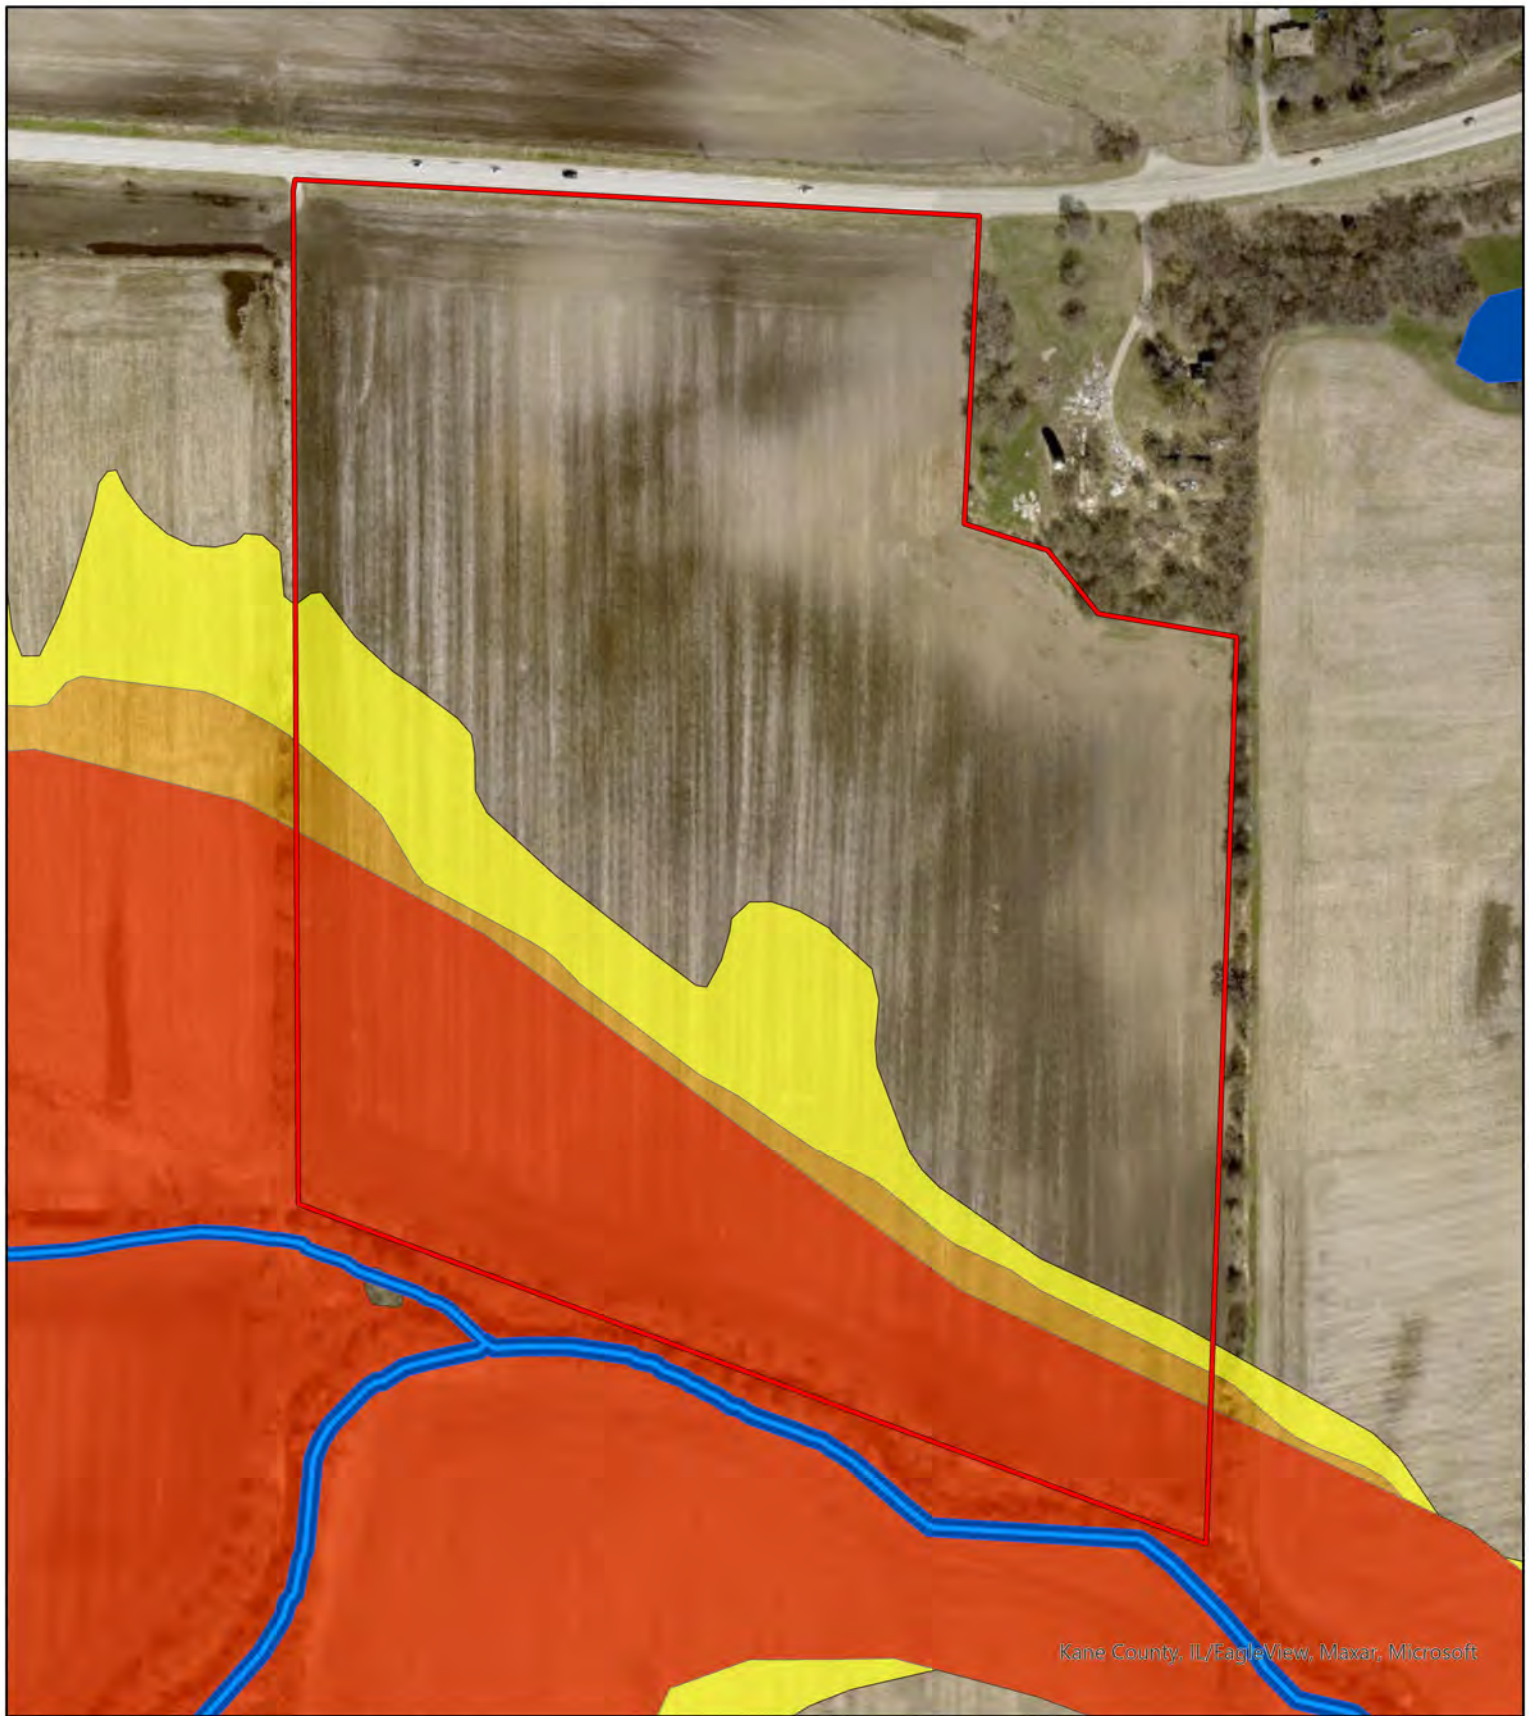
Map 3. Wetland Map

The NWI (USFWS, 2025), Illinois Public Waters (IDNR, 2025) and NHD (USGS, 2025) data sets were reviewed to document mapped wetlands and/or waterbodies within the Study Area. No features mapped within these datasets intersect the Study Area (Map 3, Appendix A). The Federal Emergency Management Agency (FEMA) flood map was also accessed to determine if the Study Area is intersected by high-risk flood zones (FEMA, 2025). The southern third of the Study Area is intersected by the floodway, 100-year floodplain, and 500-year floodplain associated with Tyler Creek (Appendix B).

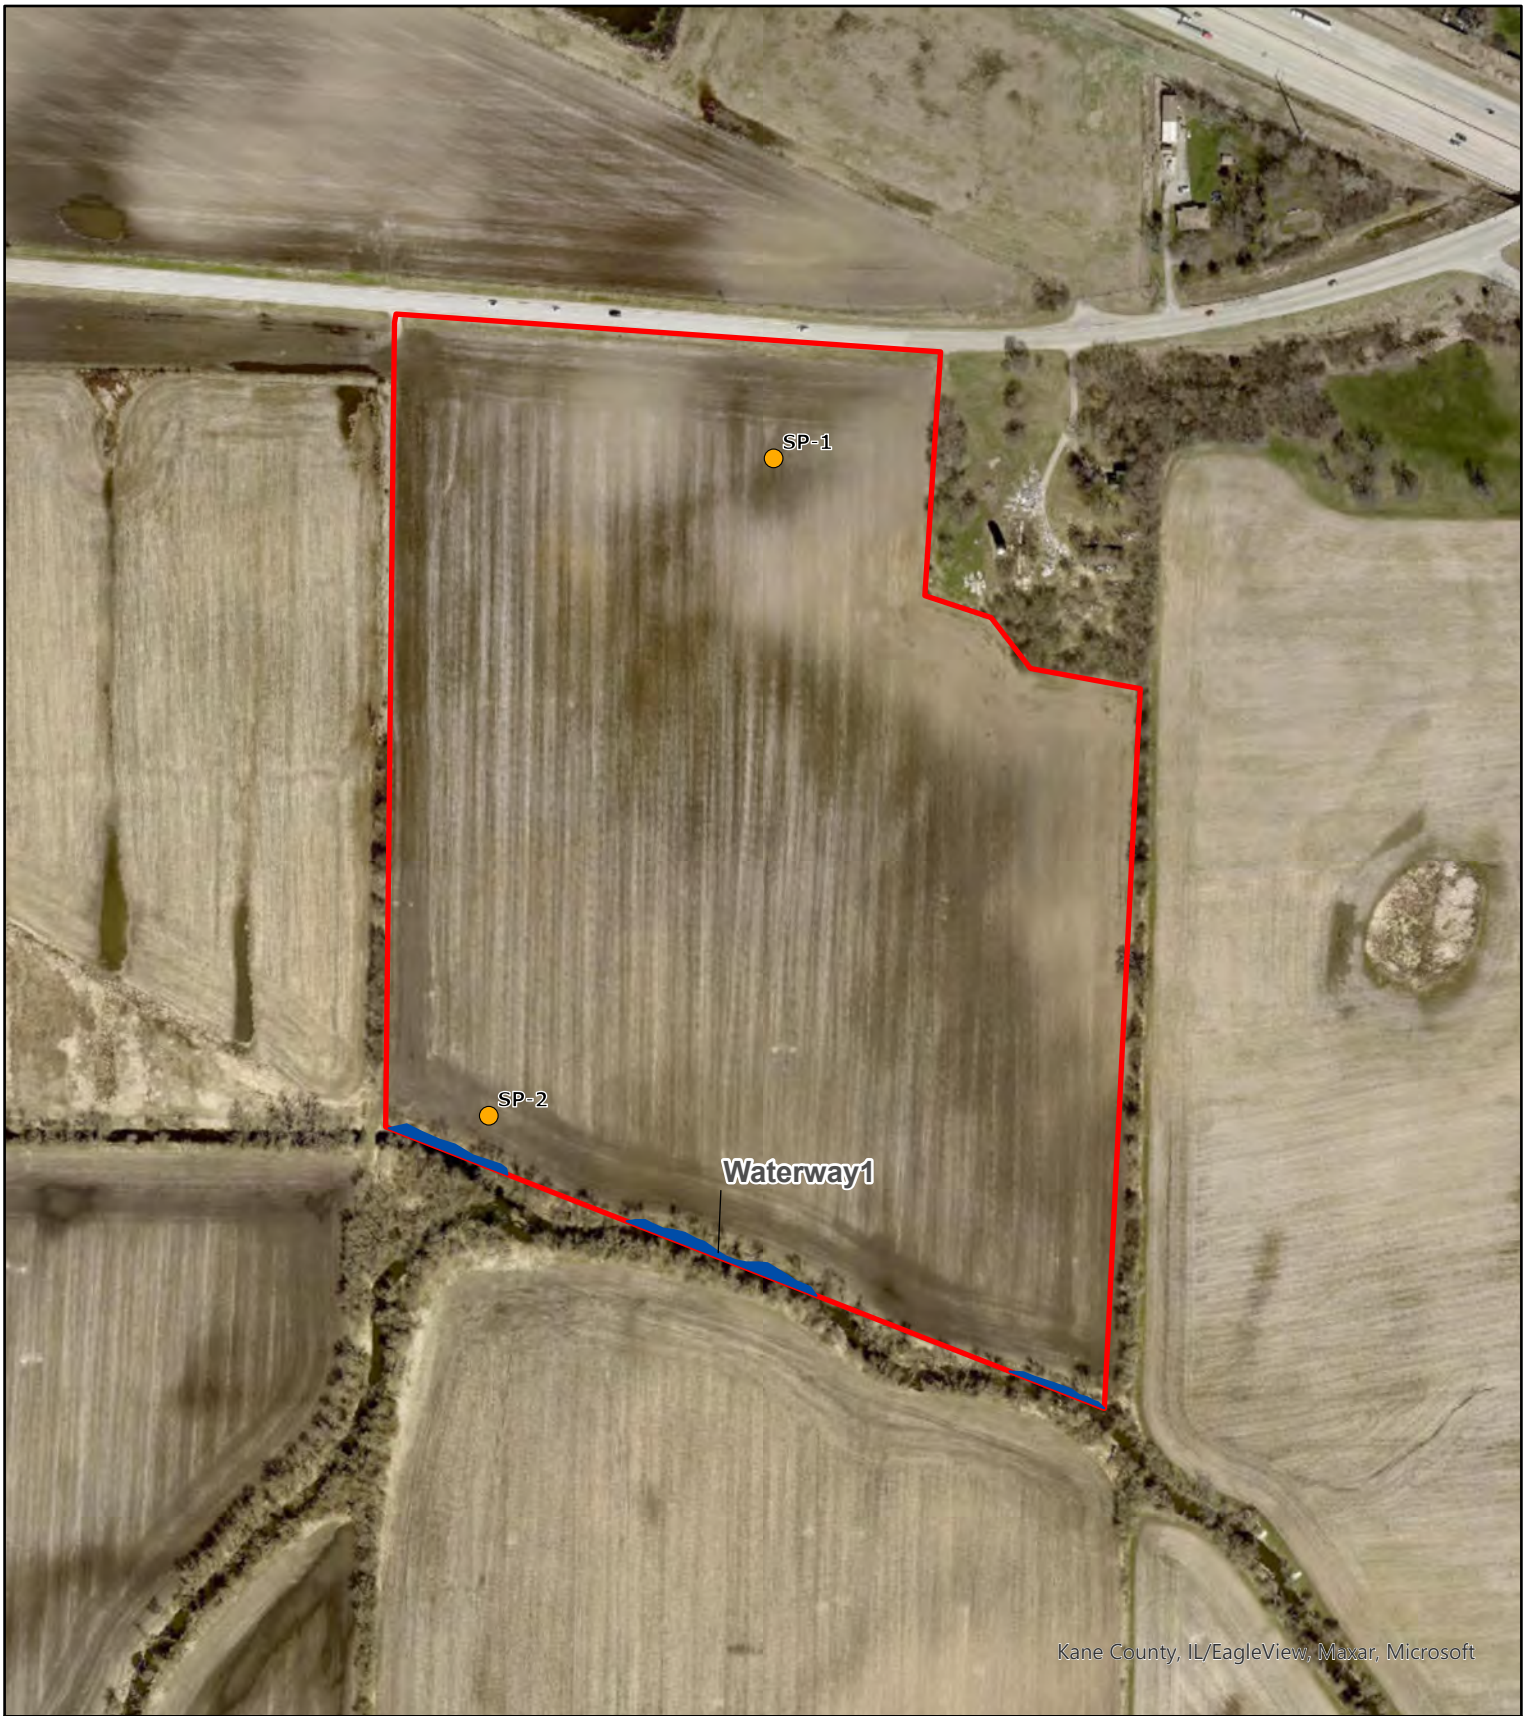
Map 5. Wetland Delineation Map

Based upon this routine Level 2 Wetland Delineation, it is the professional opinion of Area M, wetlands are absent from the Study Area and Tyler Creek intersects the southern boundary (Map 5; Appendix A).

Waterway 1 -Tyler Creek – 0.20 acres (within Study Area)

Tyler Creek encroaches into the southern portion of the Study Area. This waterway is a perennial tributary with incised banks and earthen berm along the north edge of the bank (to prevent flooding). The reach of creek which intersects the Study Area is channelized. No fringe wetlands were identified outside of the well-defined bank.

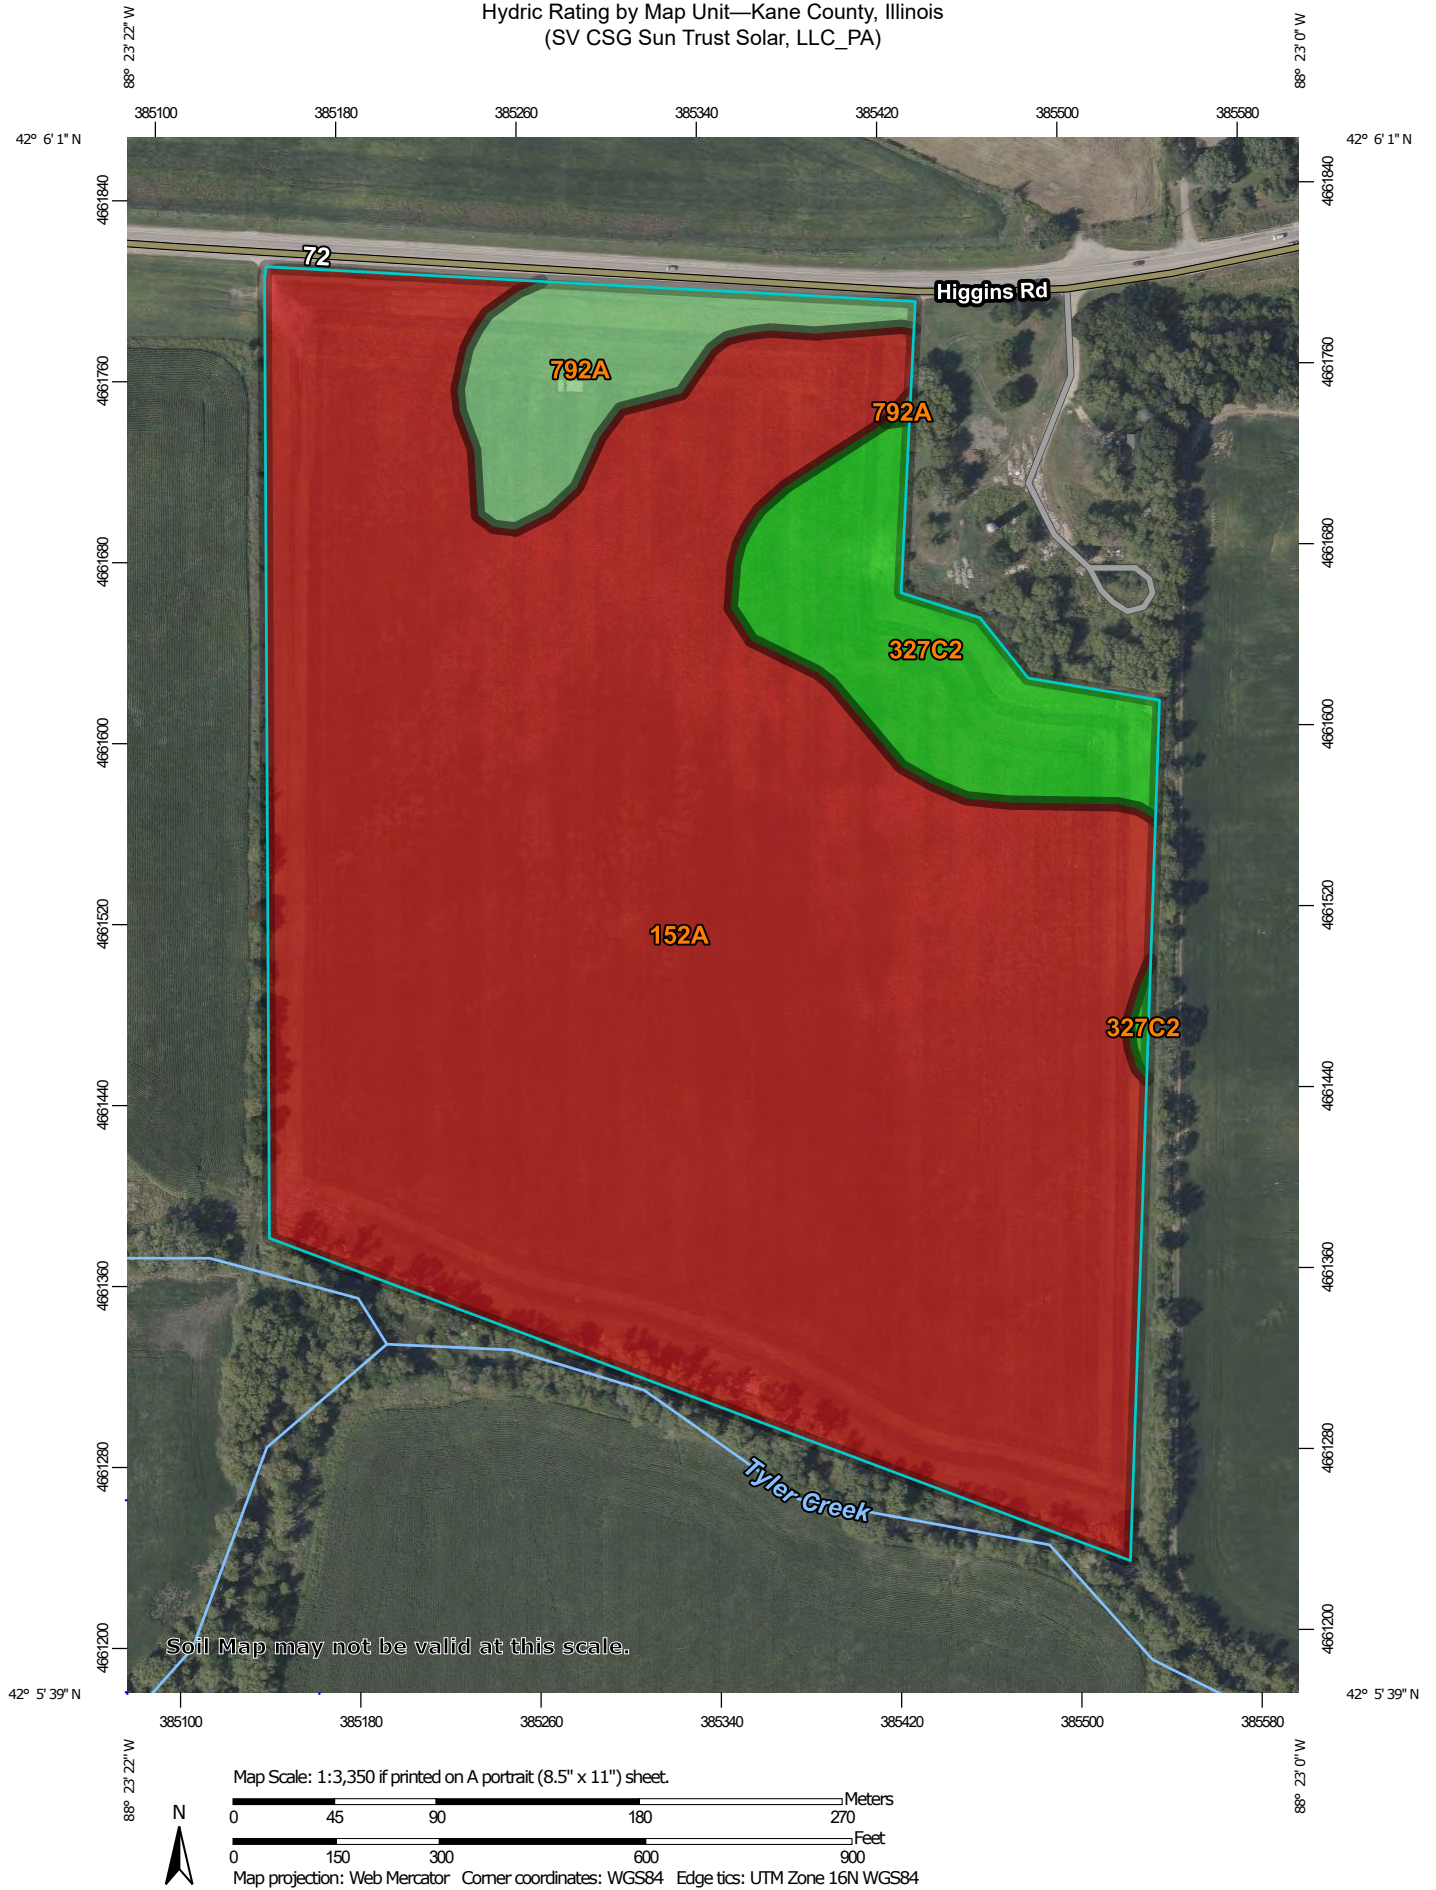
Hydric Rating by Map Unit—Kane County, Illinois (SV CSG Sun Trust Solar, LLC_PA)

The Web Soil Survey (NRCS, 2025) was reviewed to summarize mapped soil types which occur within the Study Area. Soil units 100% hydric ratings are mapped throughout the majority of the Study Area. A full list of hydric soils components and attributes are listed in Appendix C.

Map unit symbol	Map unit name	Rating	Acres in AOI	Percent of AOI
152A	Drummer silty clay loam, 0 to 2 percent slopes	100	37.5	86.3%
327C2	Fox silt loam, 4 to 6 percent slopes, eroded	0	3.6	8.4%
792A	Bowes silt loam, 0 to 2 percent slopes	6	2.3	5.4%
Totals for Area of Interest			43.5	100.0%

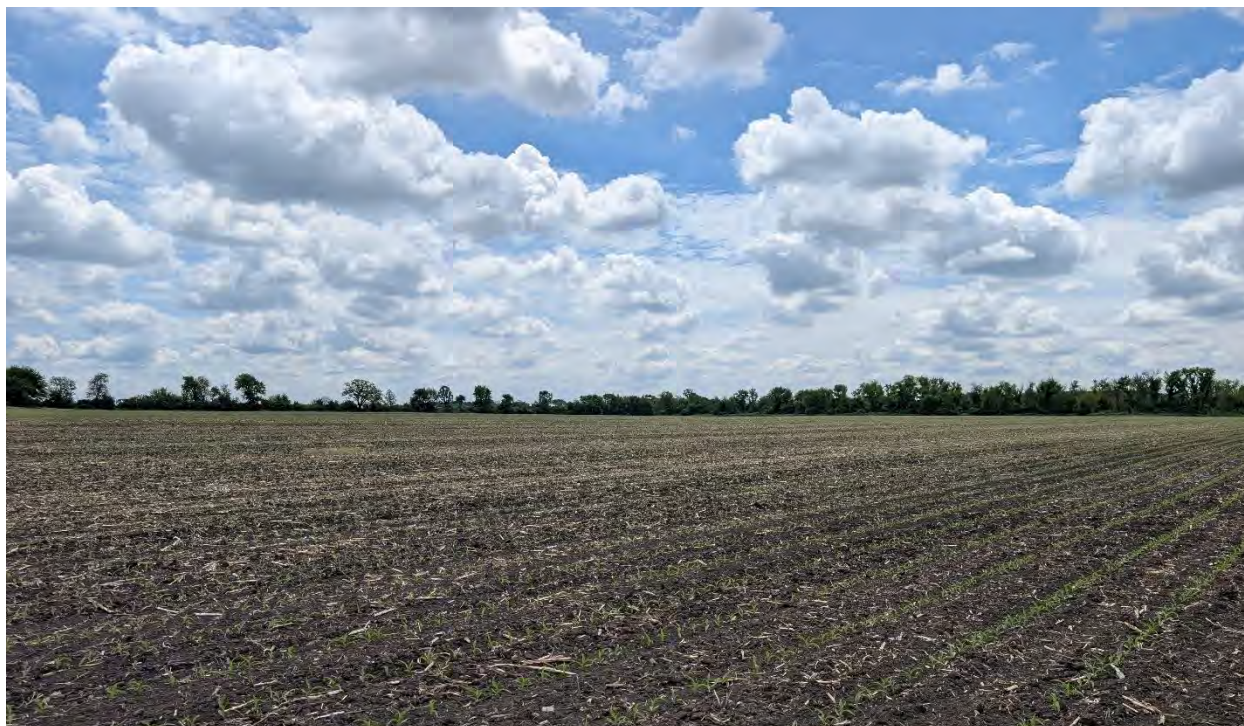
General upland landscape on landfill, viewed to the southeast from the center of the Study Area

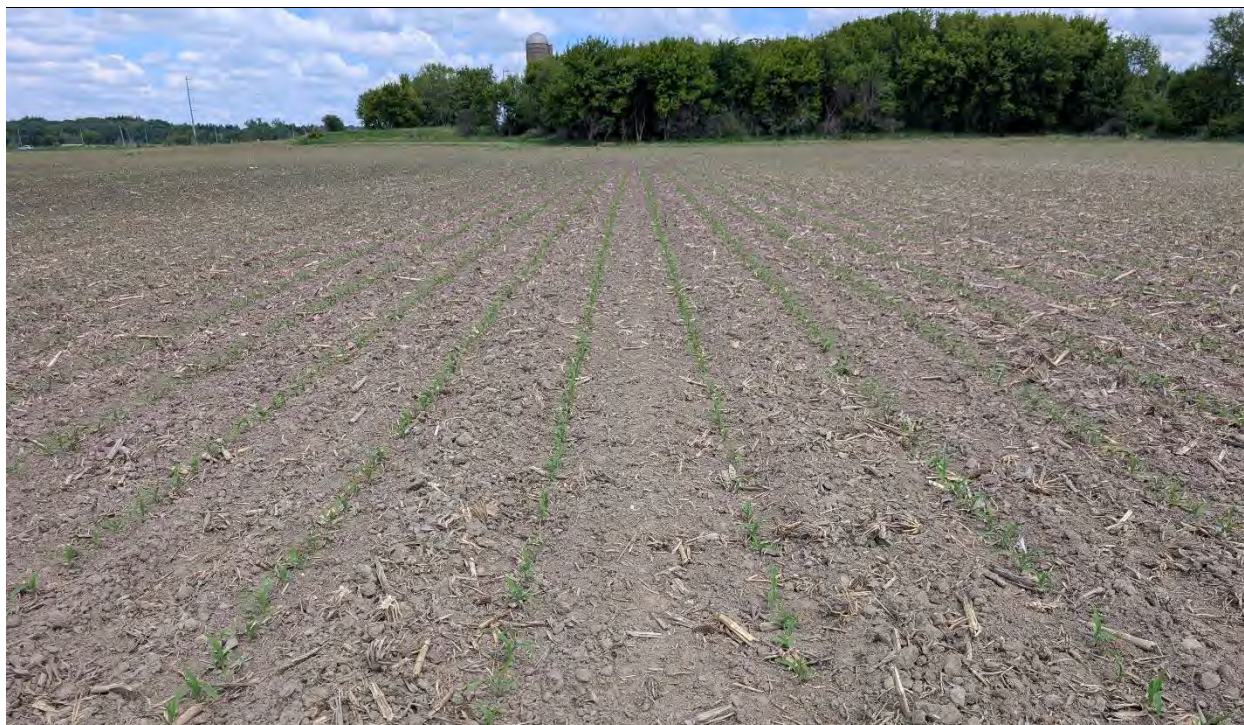
General upland Project landscape on landfill, viewed to the north from the eastern boundary of the Study Area

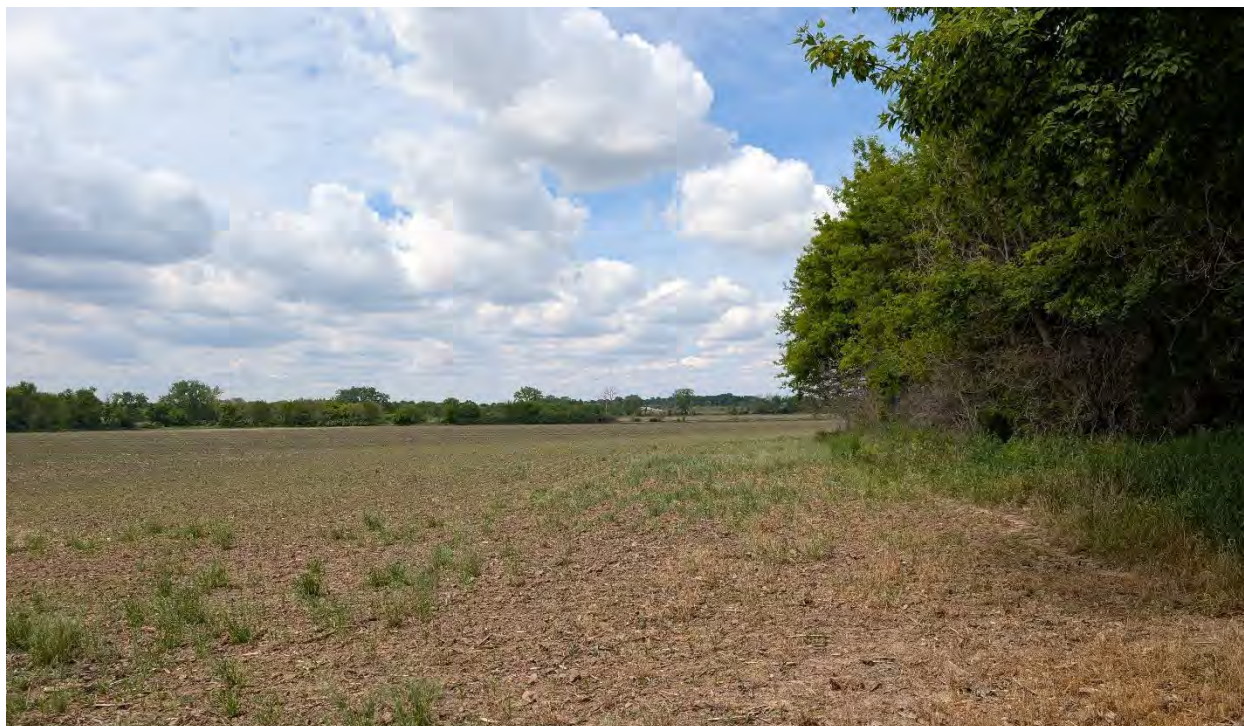
General Project landscape, viewed to the southwest from the northeastern corner of the Study Area

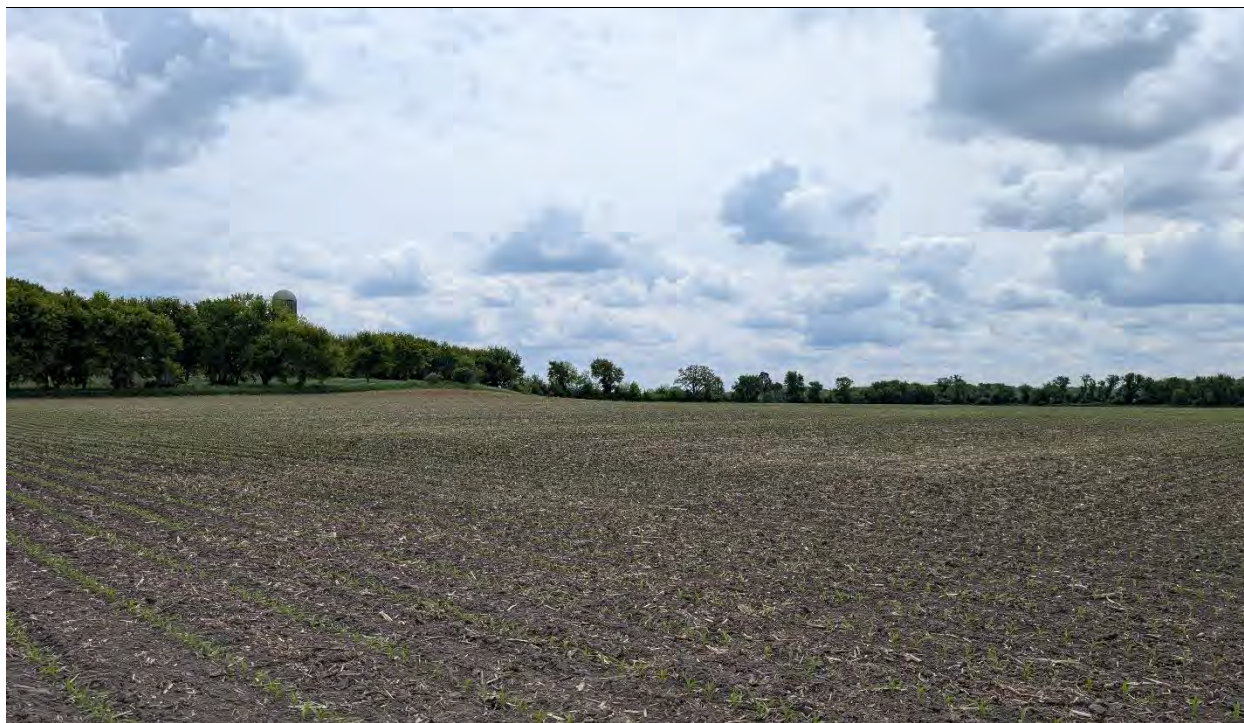
Area 1, a small, inconspicuous depression identified during the off-site review, is located with the cropped field in the north-central portion of the Study Area. However, this area showed wetland hydrology signatures in 1 of 11 slides with normal antecedent precipitation (4 of 21 overall). Therefore, this area was determined to be upland. During the field visit, the depression was difficult to identify in the field. At SP 1, in the center of the feature, soils were hydric but wetland hydrology was not observed. The plant community was not evaluated or used as wetland criteria due to cropping.

Area 1 (inconspicuous depression), viewed to the southeast from the northwest of the feature

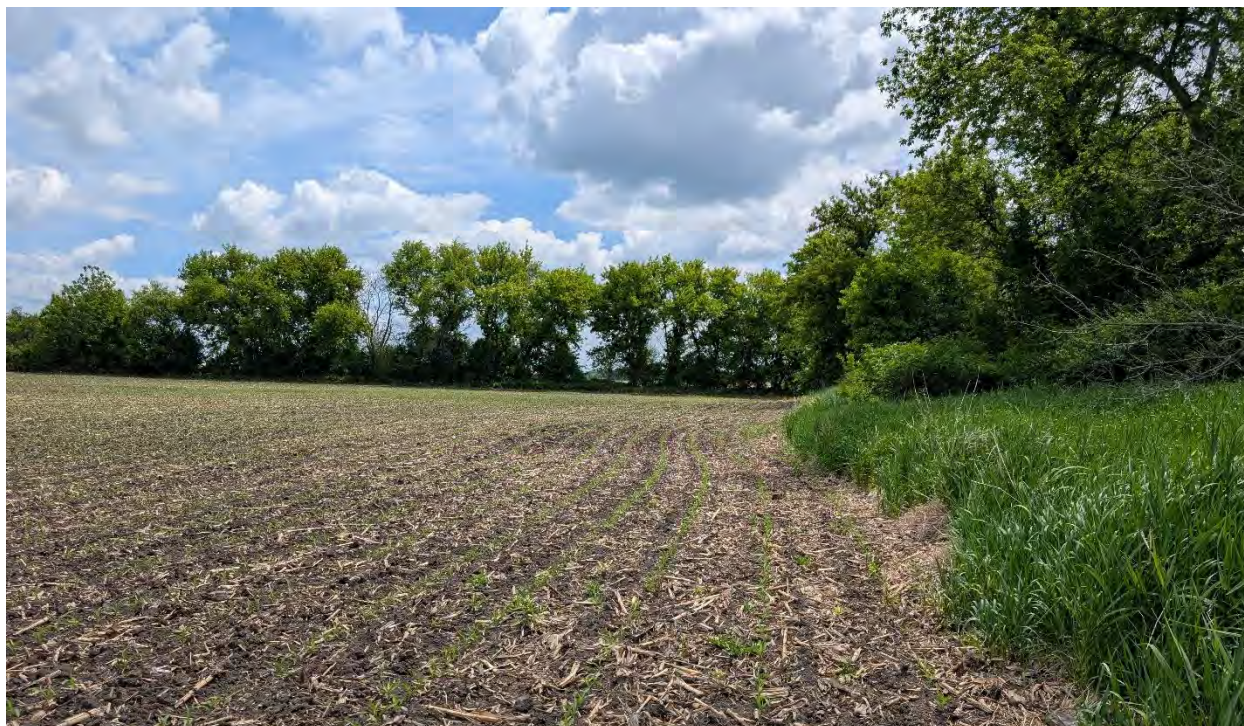
Area 2, the flat floodplain associated with Tyler Creek, includes the cropped field in the southern third of the Study Area. However, this area showed wetland hydrology signatures in 2 of 11 slides with normal antecedent precipitation (5 of 21 overall). Therefore, this area was determined to be upland. At SP 2, in the

lower portion of the floodplain, soil was hydric but wetland hydrology was not observed. The plant community was not evaluated or used as wetland criteria due to cropping.

Area 2, the floodplain, viewed to the east from the southern edge of the Study Area

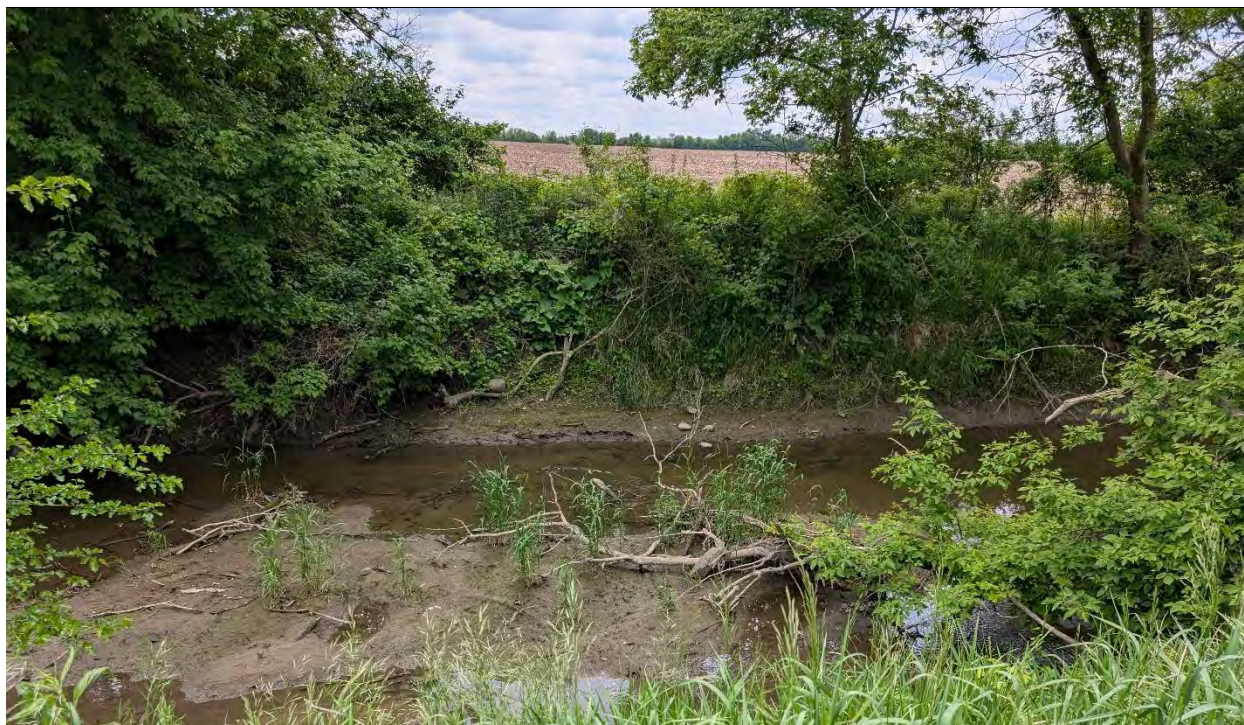
Tyler Creek, a ditch, viewed to the south from beyond the southern extent of the Study Area
