Aquatic Resources Delineation Report

Orchard Solar
Jericho Road (IL-24)
Sugar Grove, Kane County Illinois
Terracon Project No. 11257022
July 11, 2025

Re: Aquatic Resource Delineation Report

Orchard Solar
Jericho Road (IL-24)
Sugar Grove, Kane County, Illinois 60506
Terracon Project No. 11257022

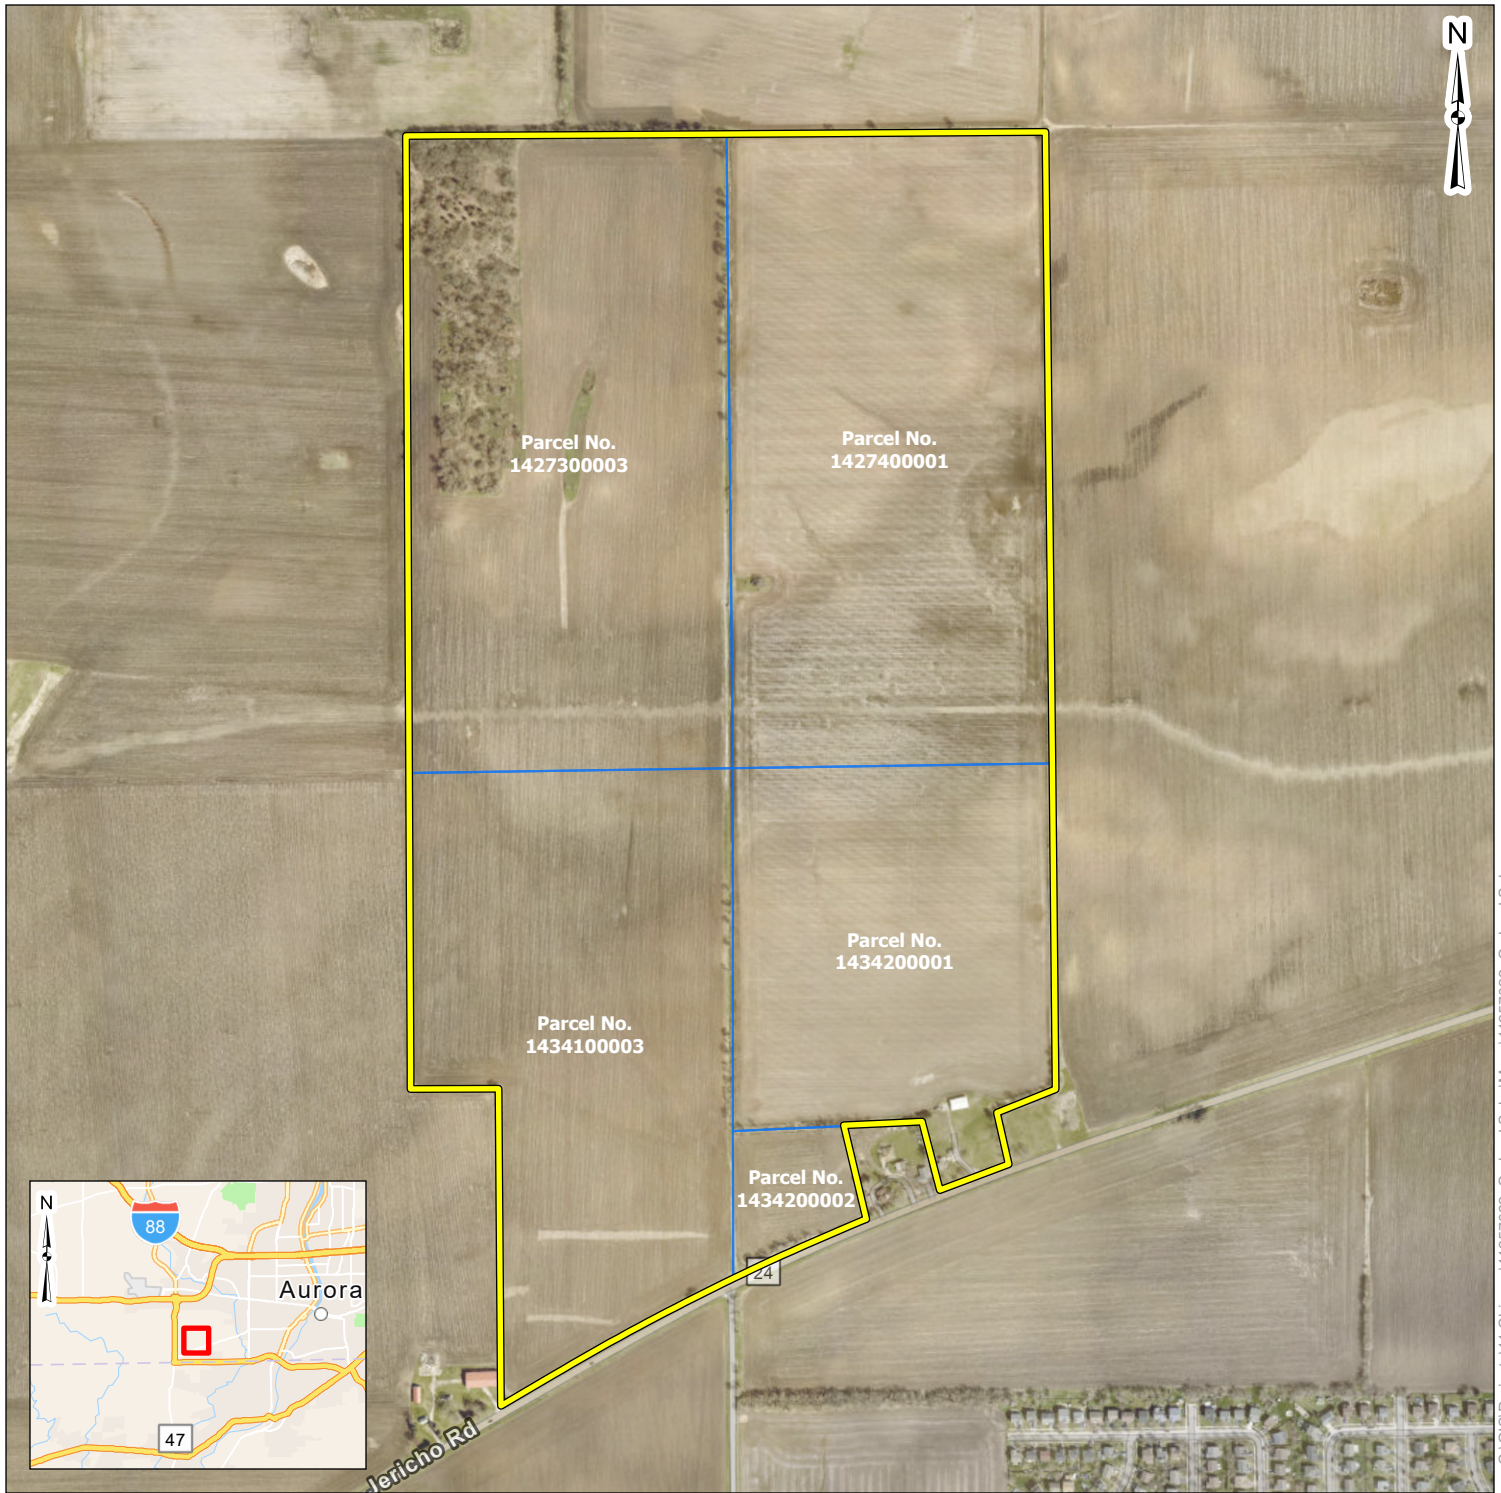
1

Study Area (297.57 ac.±)

Terracon Consultants, Inc., (Terracon) was retained by Clean Field Power LLC (Client) to perform an aquatic resources delineation for approximately 279.57 acres of land located at Jericho Rd, Sugar Grove, Kane County, Illinois (study area), as depicted on *Exhibit 1.0* in *Appendix A*.

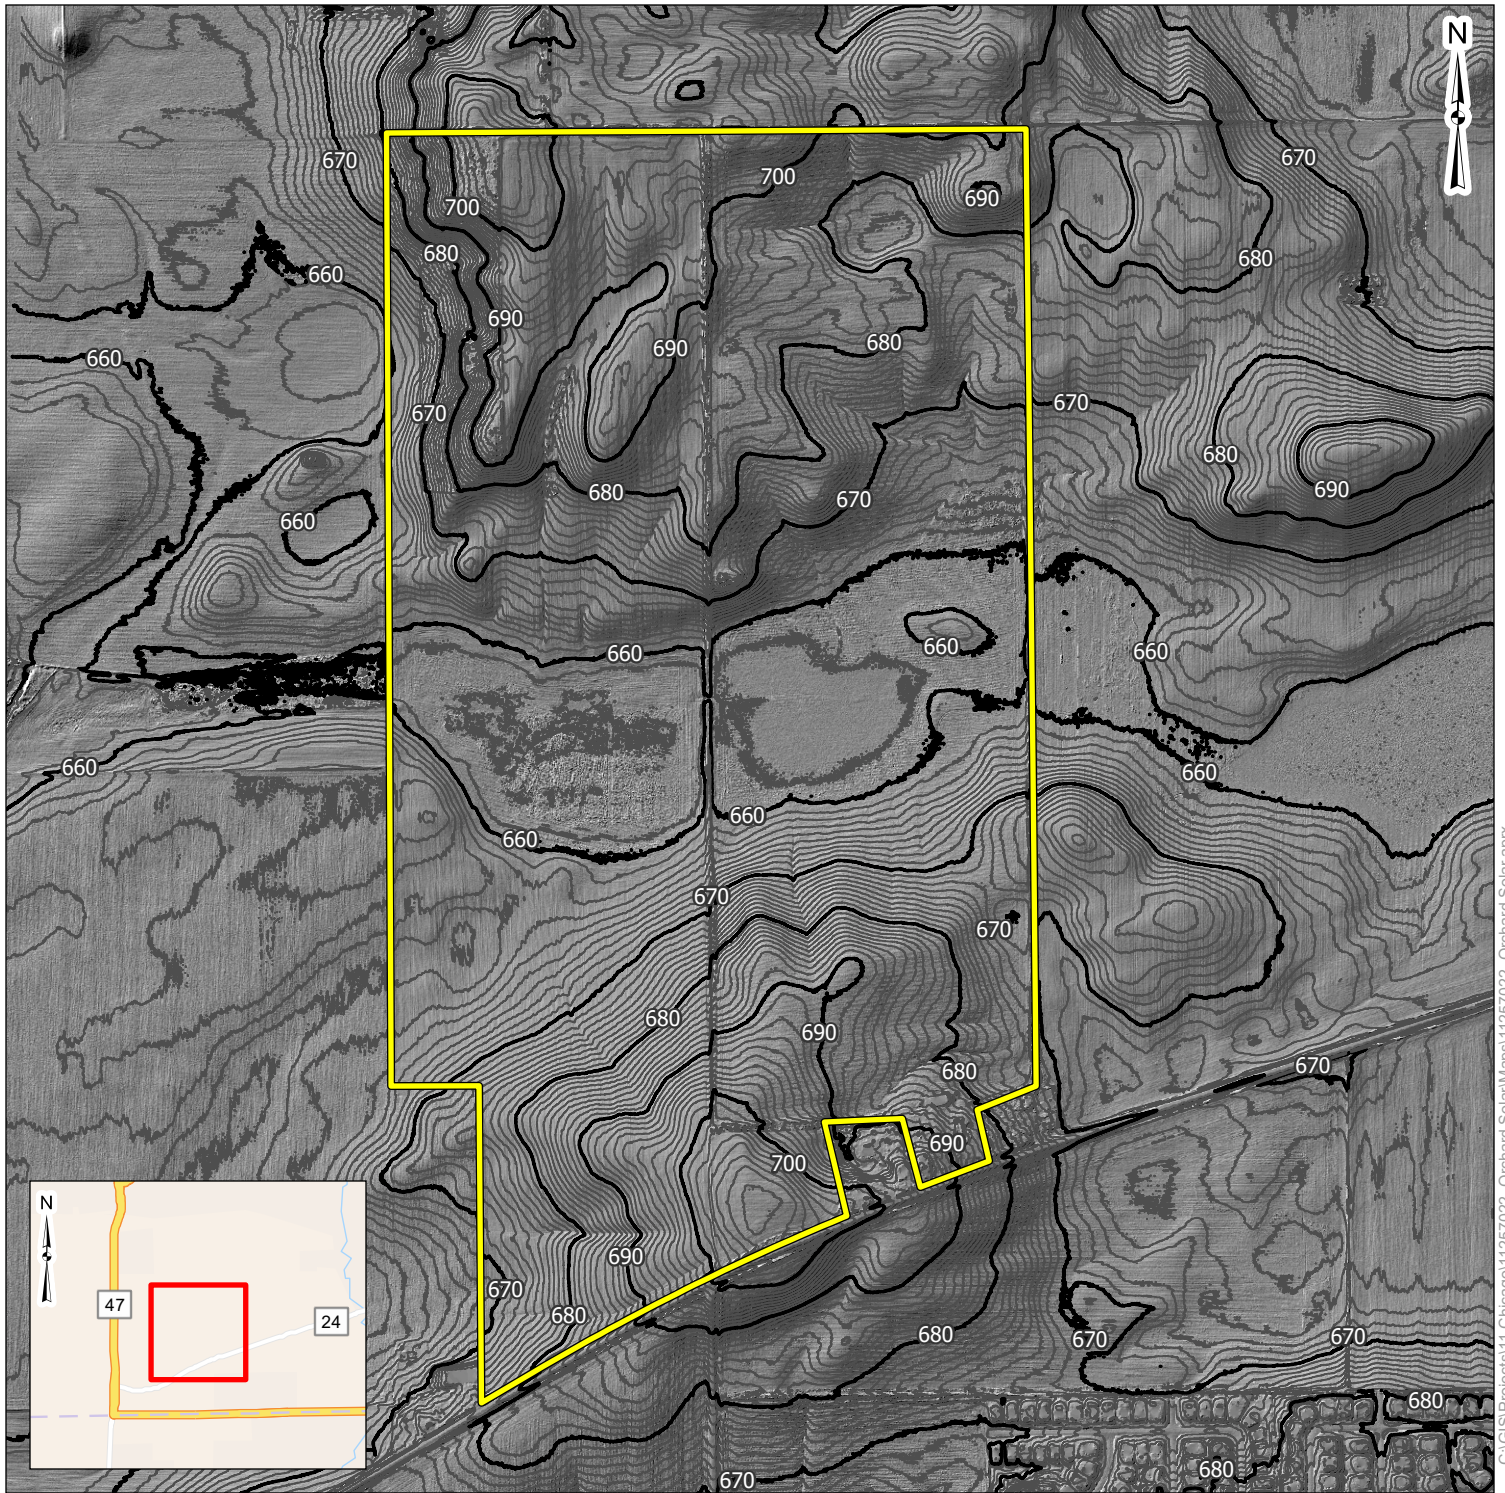
- Study Area
- Index Contour
- Intermediate Contour

The USGS 7.5-Minute Series topographic maps (1:24,000) for the Yorkville, Illinois quadrangle (2024) and the Light Detection and Ranging (LiDAR)¹ topography map was evaluated to preliminarily identify drainages, creeks, ponds, wetlands, and other aquatic features, as well as characterize vegetation and potential areas of habitat within the study area. The USGS quadrangle maps depict elevations ranging from approximately 670 to 700 feet above mean sea level (msl). The study area slopes down from Jericho Road moving north to the center of the site containing potential wetlands, indicated by the blue symbols on the map. The site then slopes up towards the northern site boundary. The northwestern portion of the site contains a small, wooded area depicted by green shading. The site is depicted as undeveloped vacant land abutting Jericho Road to the south. There are a few houses with garages/shops depicted near the southeast corner of the site. *Exhibit 2 (Appendix A)* depicts the USGS topographic map in the vicinity of the study area and *Exhibit 3 (Appendix A)* depicts the LiDAR topography (1-foot elevation contours) of the study area and surrounding areas.

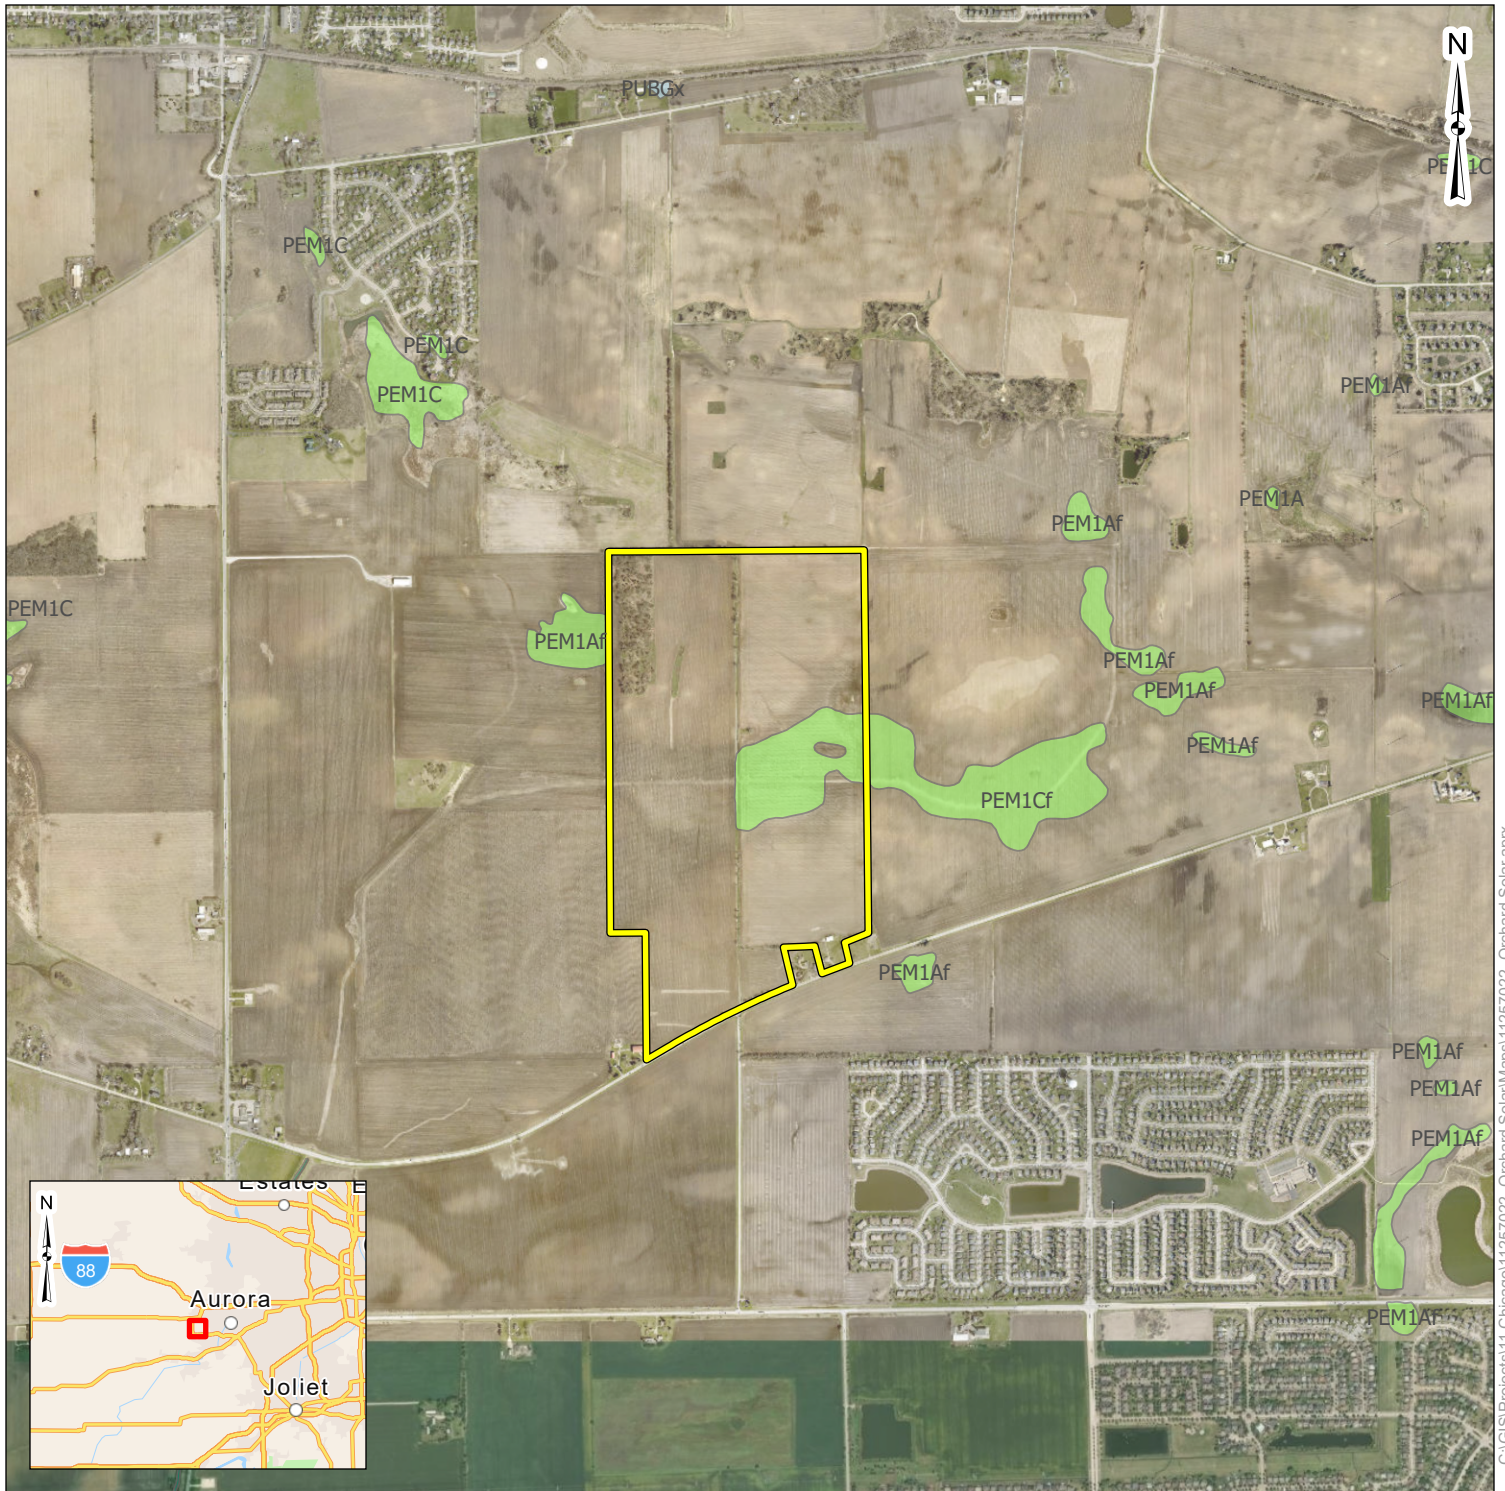
Exhibit
4

- Study Area
- National Wetlands Inventory
- Freshwater Emergent Wetland
- Freshwater Pond
- Riverine

A palustrine emergent persistent seasonally flooded, farmed wetland (PEM1Cf) is depicted in the central portion of the study area. NWI features surrounding the study area are depicted atop recent aerial imagery in *Exhibit 4 of Appendix A*.

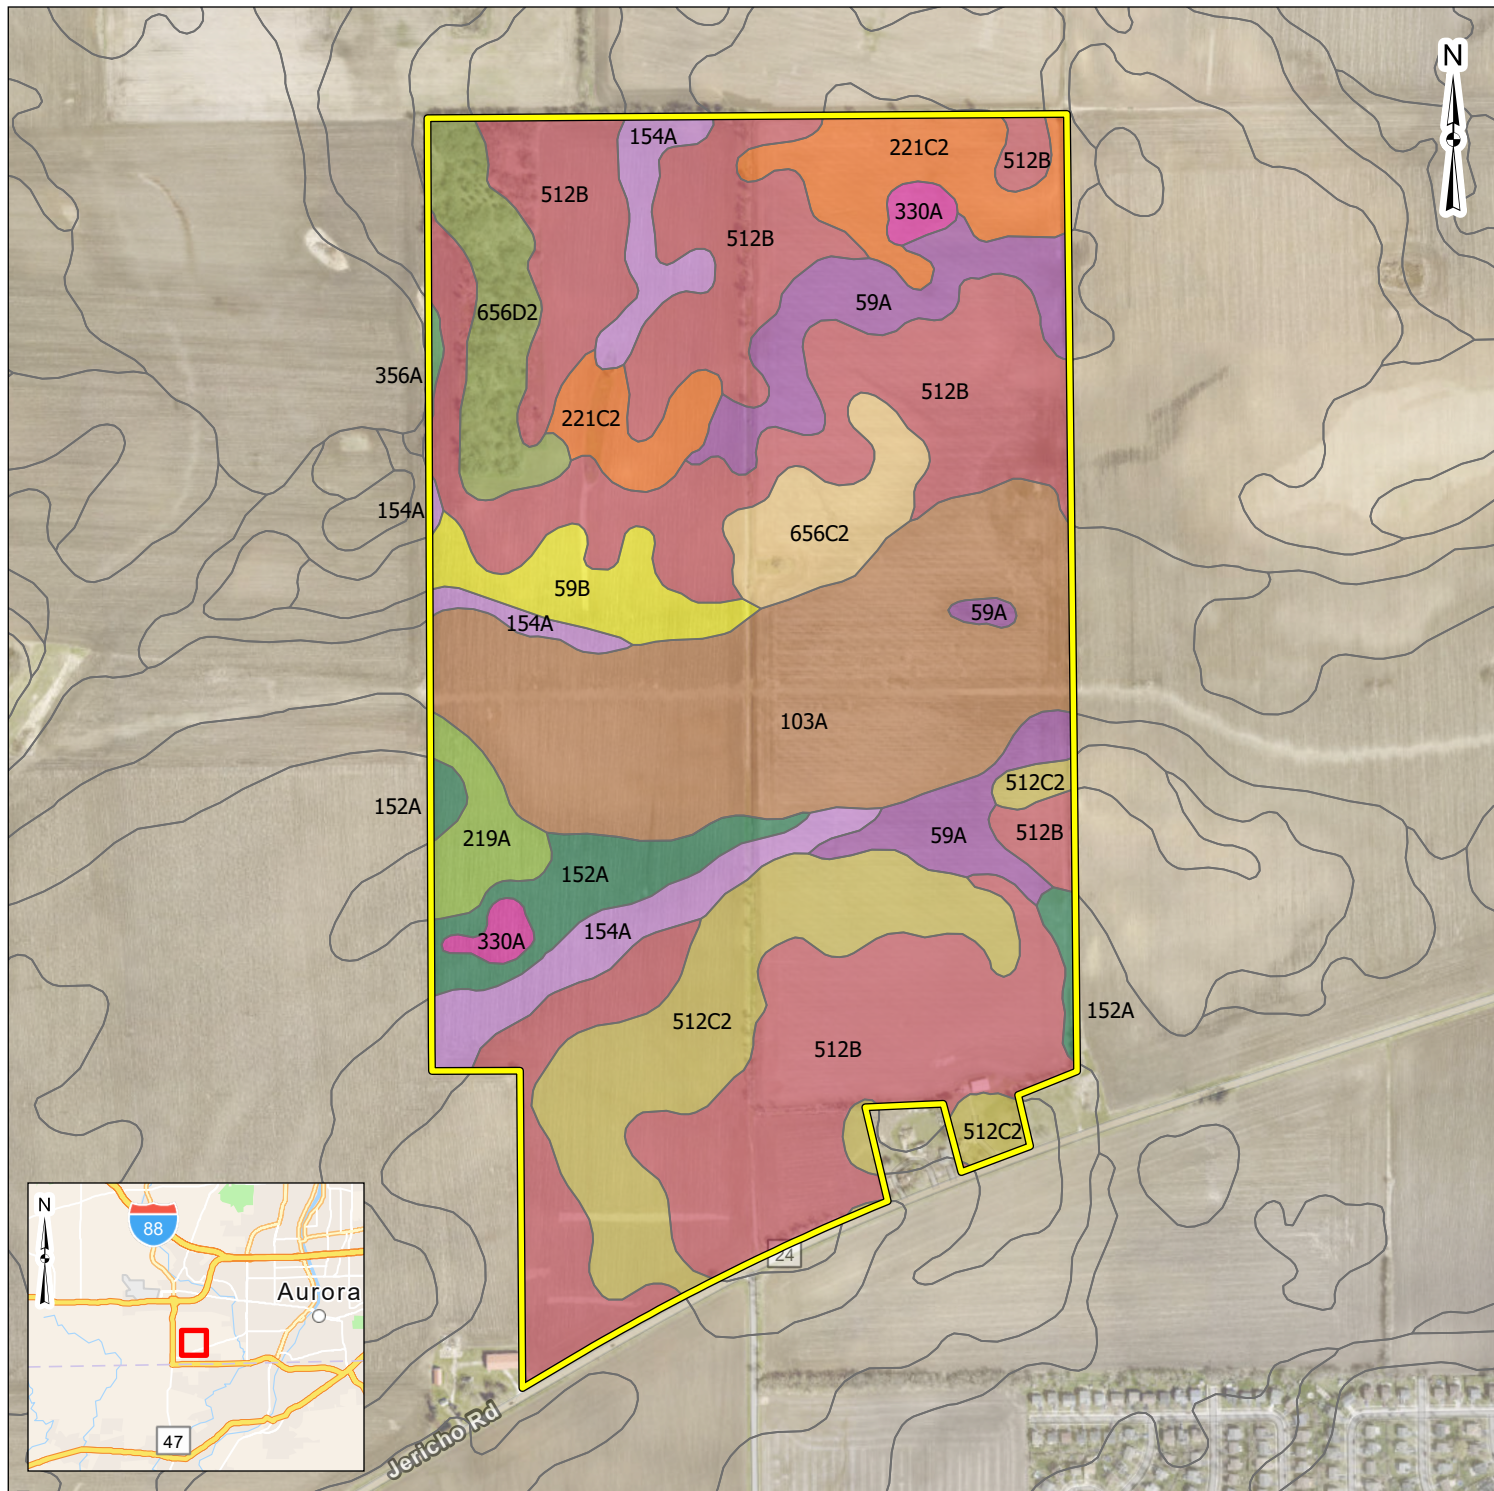
5

Study Area

SSURGO Soils

Data from the USDA Natural Resource Conservation Service (NRCS) Web Soil Survey and the State Soil Data Access Hydric Soils List were reviewed to characterize soils within the study area and vicinity, accessed July 8, 2025. The study area is located within thirteen soil units. *Table 1* contains a summary of the mapped soil unit within the study area and relevant physical characteristics. The USDA NRCS soil survey map for the study area is included as *Exhibit 5*.

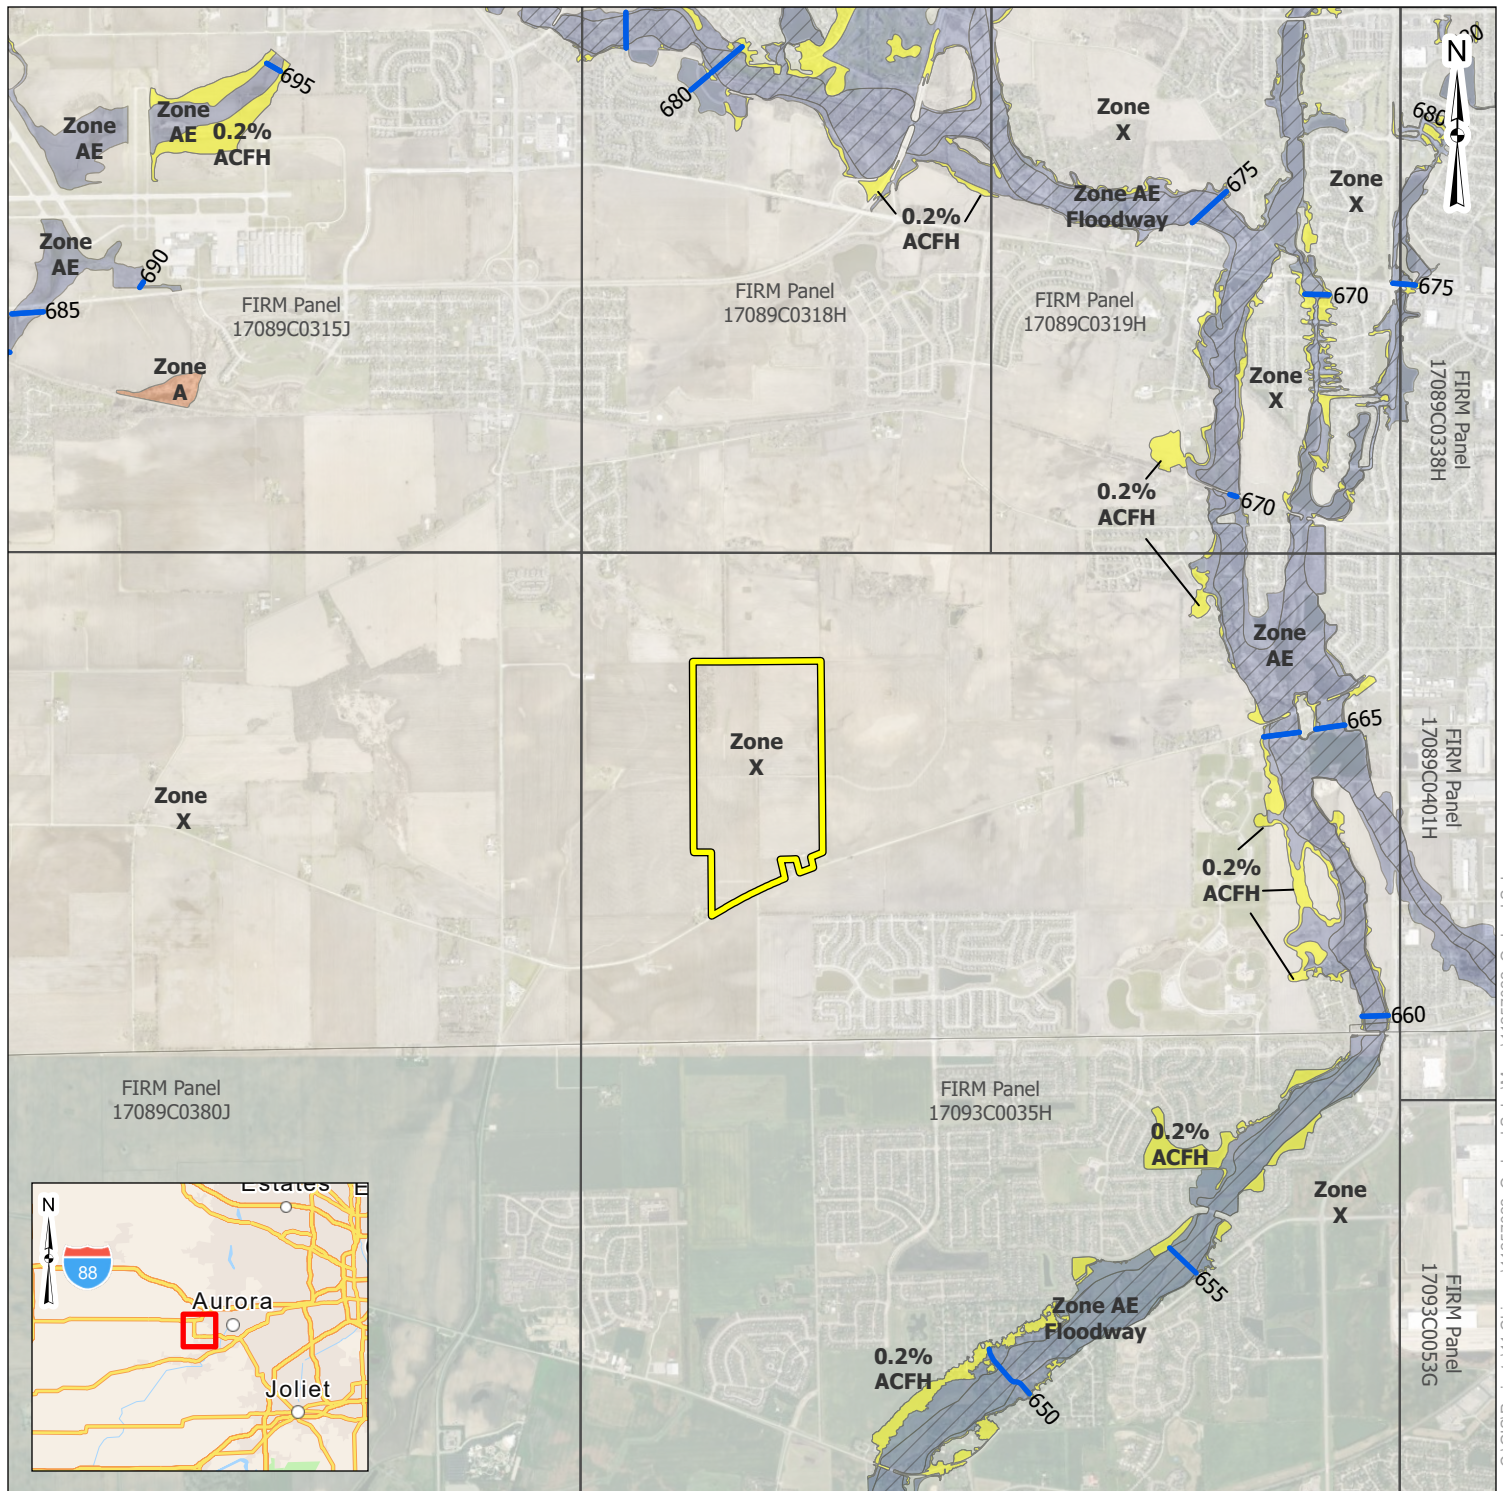
6

- Study Area
- FIRM Panel
- Base Flood Elevation (Feet)

DATA SOURCES:
 FEMA - Preliminary Flood Hazard Zones for Kane County, IL, FIRM Panel - 117093C0035H Effective 1/8/2014; ESRI - World Imagery Basemap & World Navigation Map

Terracon downloaded and reviewed the FEMA National Flood Hazard Layer (NFHL) panel 117093C0035H, effective January 8, 2014. According to the NFHL, the study area is depicted within Zone X: area of minimal flood hazard. A map depicting the digital NFHL is included as *Exhibit 6* in *Appendix A*.

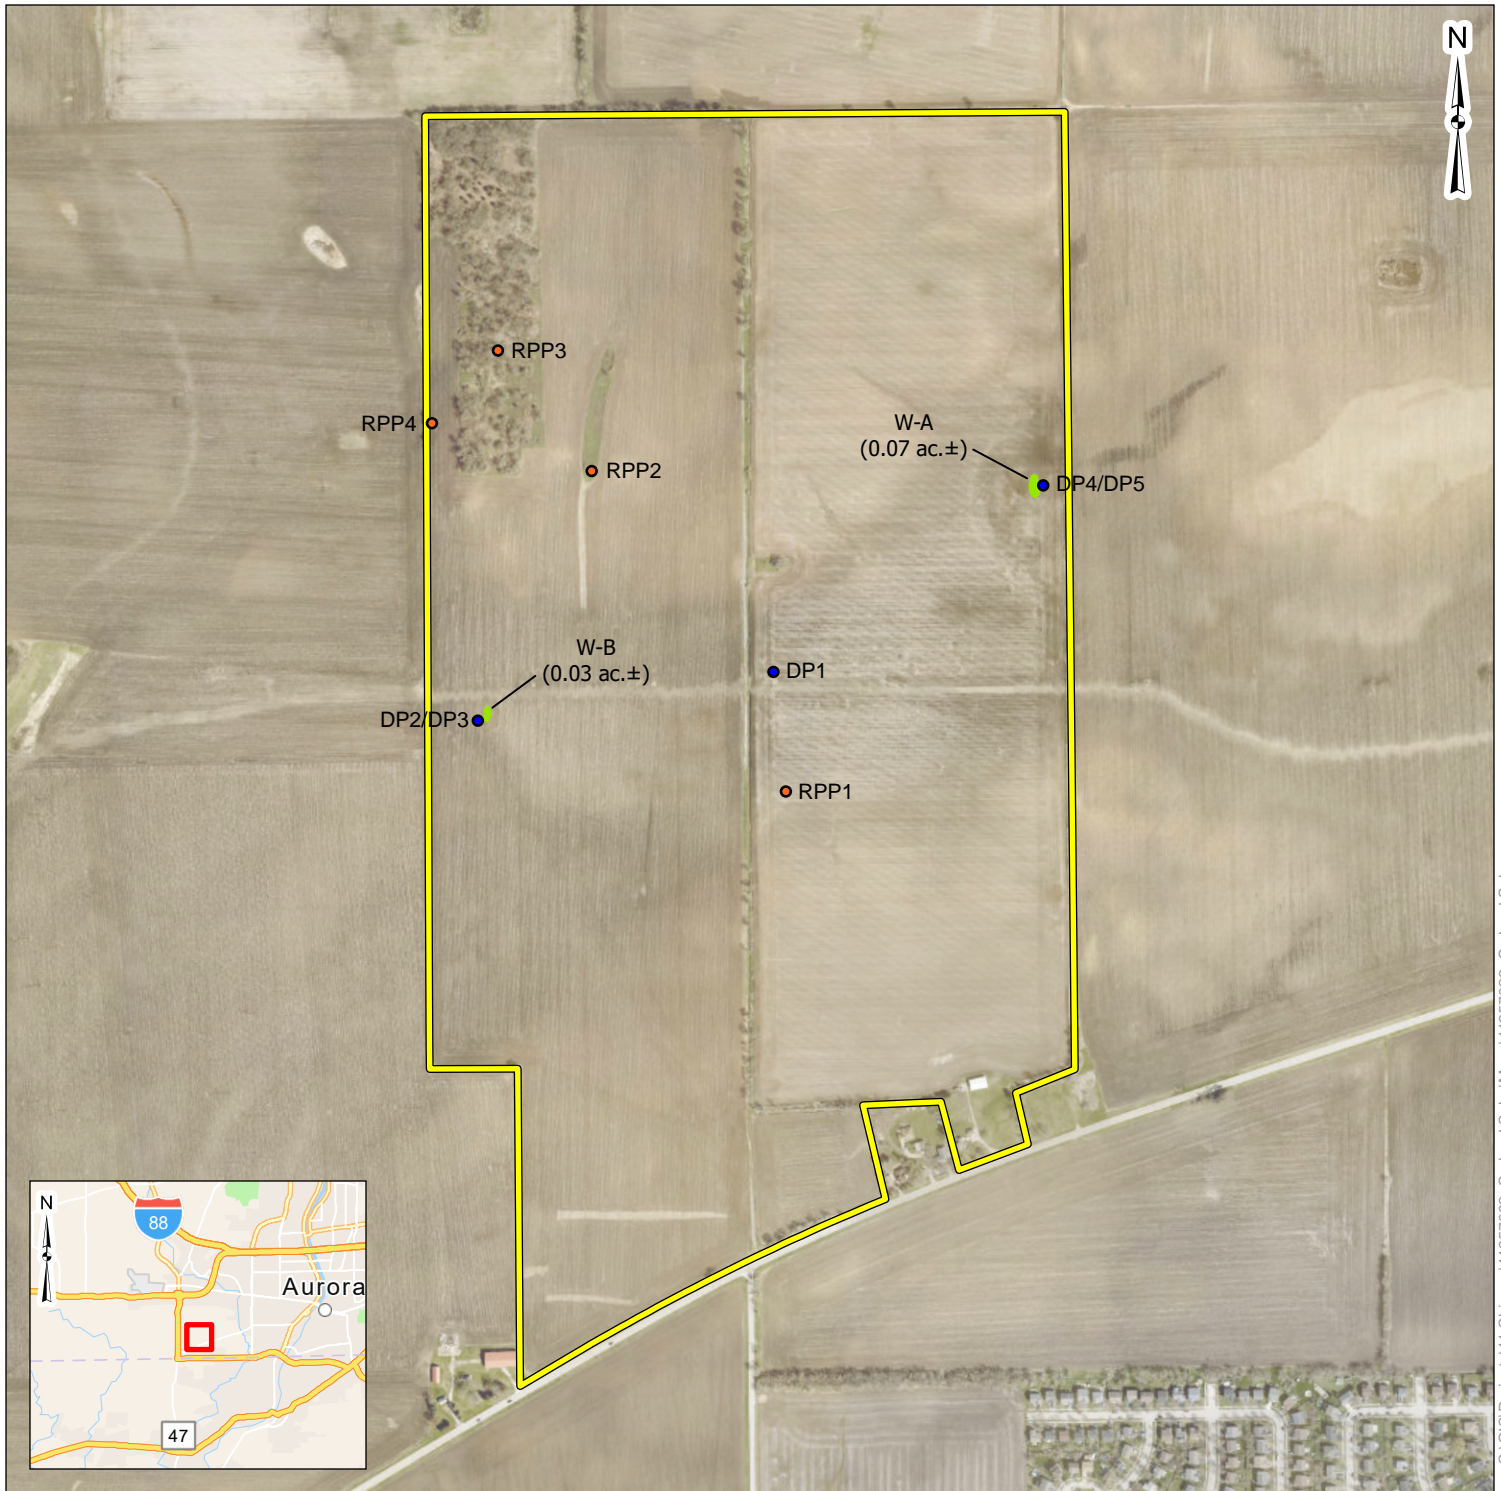
- Study Area (279.57 ac.±)
- Wetlands (0.10 ac.±)
- Data Point Location
- Reference Photo Point (RPP) Location

- **WA:** A ±0.07-acre emergent wetland was observed near the eastern boundary of the study area. This wetland appears to be a remnant feature within a former larger wetland area on the study area that has been hydrologically impacted by the installation of drain tile. Dominant vegetation observed included reed canary grass (*Phalaris arundinacea*), and hybrid cattail (*Typha x glauca*). DP-4 documents the wetland characteristics. Muck soils were observed. While primary hydrology indicators were not observed during the site reconnaissance, secondary hydrology indicators included saturation visible on aerial imagery, and positive FAC-Neutral test.

- **WB:** A ±0.03-acre emergent wetland was observed near the western boundary of the study area. This wetland also appears to be a remnant feature within a former larger wetland area on the study area that has been hydrologically impacted by the installation of drain tile. Dominant vegetation observed included reed canary grass (*Phalaris arundinacea*), curly doc (*Rumex crispus*), and white mulberry (*Morus alba*). DP-2 documents the wetland characteristics. Muck soils were observed. While primary hydrology indicators were not observed during the site reconnaissance, secondary hydrology indicators included saturation visible on aerial imagery, and positive FAC-Neutral test.

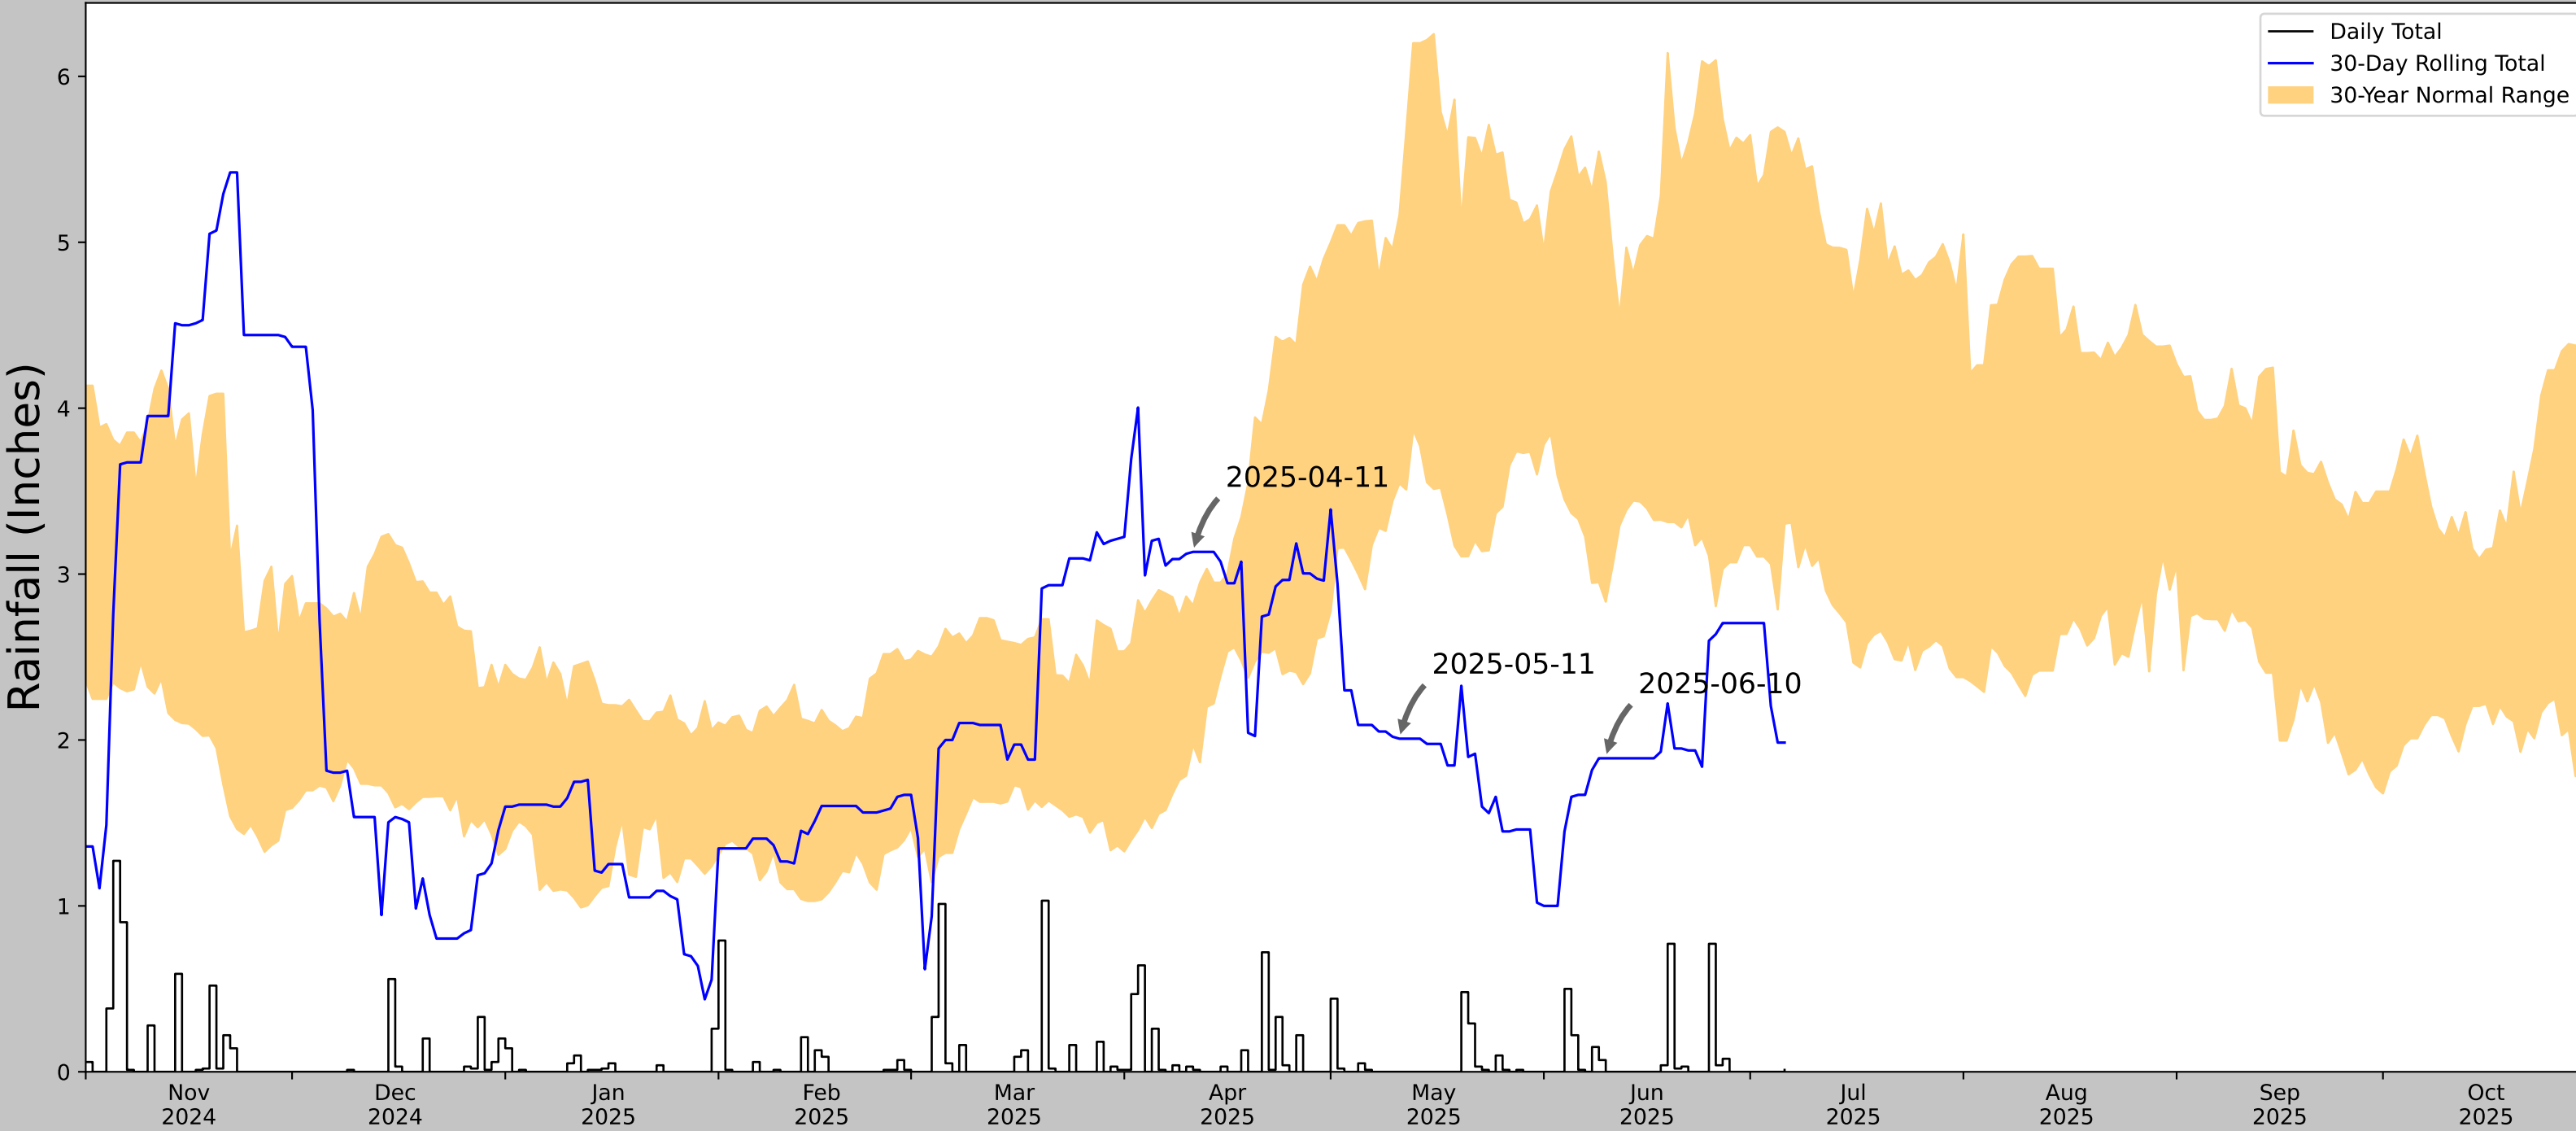
Antecedent Precipitation vs Normal Range based on NOAA's Daily Global Historical Climatology Network

Coordinates	41.737191, -88.424270
Observation Date	2025-06-10
Elevation (ft)	658.677
Drought Index (PDSI)	Moderate drought (2025-05)
WebWIMP H ₂ O Balance	Dry Season

30 Days Ending	30 th %ile (in)	70 th %ile (in)	Observed (in)	Wetness Condition	Condition Value	Month Weight	Product
2025-06-10	2.833071	5.361811	1.889764	Dry	1	3	3
2025-05-11	3.546851	5.163386	2.007874	Dry	1	2	2
2025-04-11	1.972835	2.810236	3.133858	Wet	3	1	3
Result							Drier than Normal - 8

Tables 2 and *3* summarize the DAREM index data for the study area at the time of the field investigation on June 10, 2025. According to the DAREM, the study area was experiencing drier than normal hydrologic conditions. Additionally, daily rainfall accumulation data from the Aurora Water weather station (located approximately 6.6 miles east of the study area) indicated that the study area received a total of 0.95 inches of rainfall the 7 days prior to fieldwork. Data obtained from the USACE Antecedent Precipitation Tool is included in *Appendix C*.
