RE: Water Resource Determination, ILSolar07 LLC

On November 17, 2025, Davey Resource Group, Inc. (DRG) conducted a water resource determination for the approximately 29-acre site located north of Read Road in Kane County, Illinois. The study area was evaluated by Patrick Ewbank and Kelly Volansky in accordance with the procedures outlined in the *1987 U.S. Army Corps of Engineers Wetlands Delineation Manual and the Regional Supplement to the Corps of Engineers Wetland Delineation Manual: Midwest Region*.

Appendix A: Study Area Photo Points and Data Points

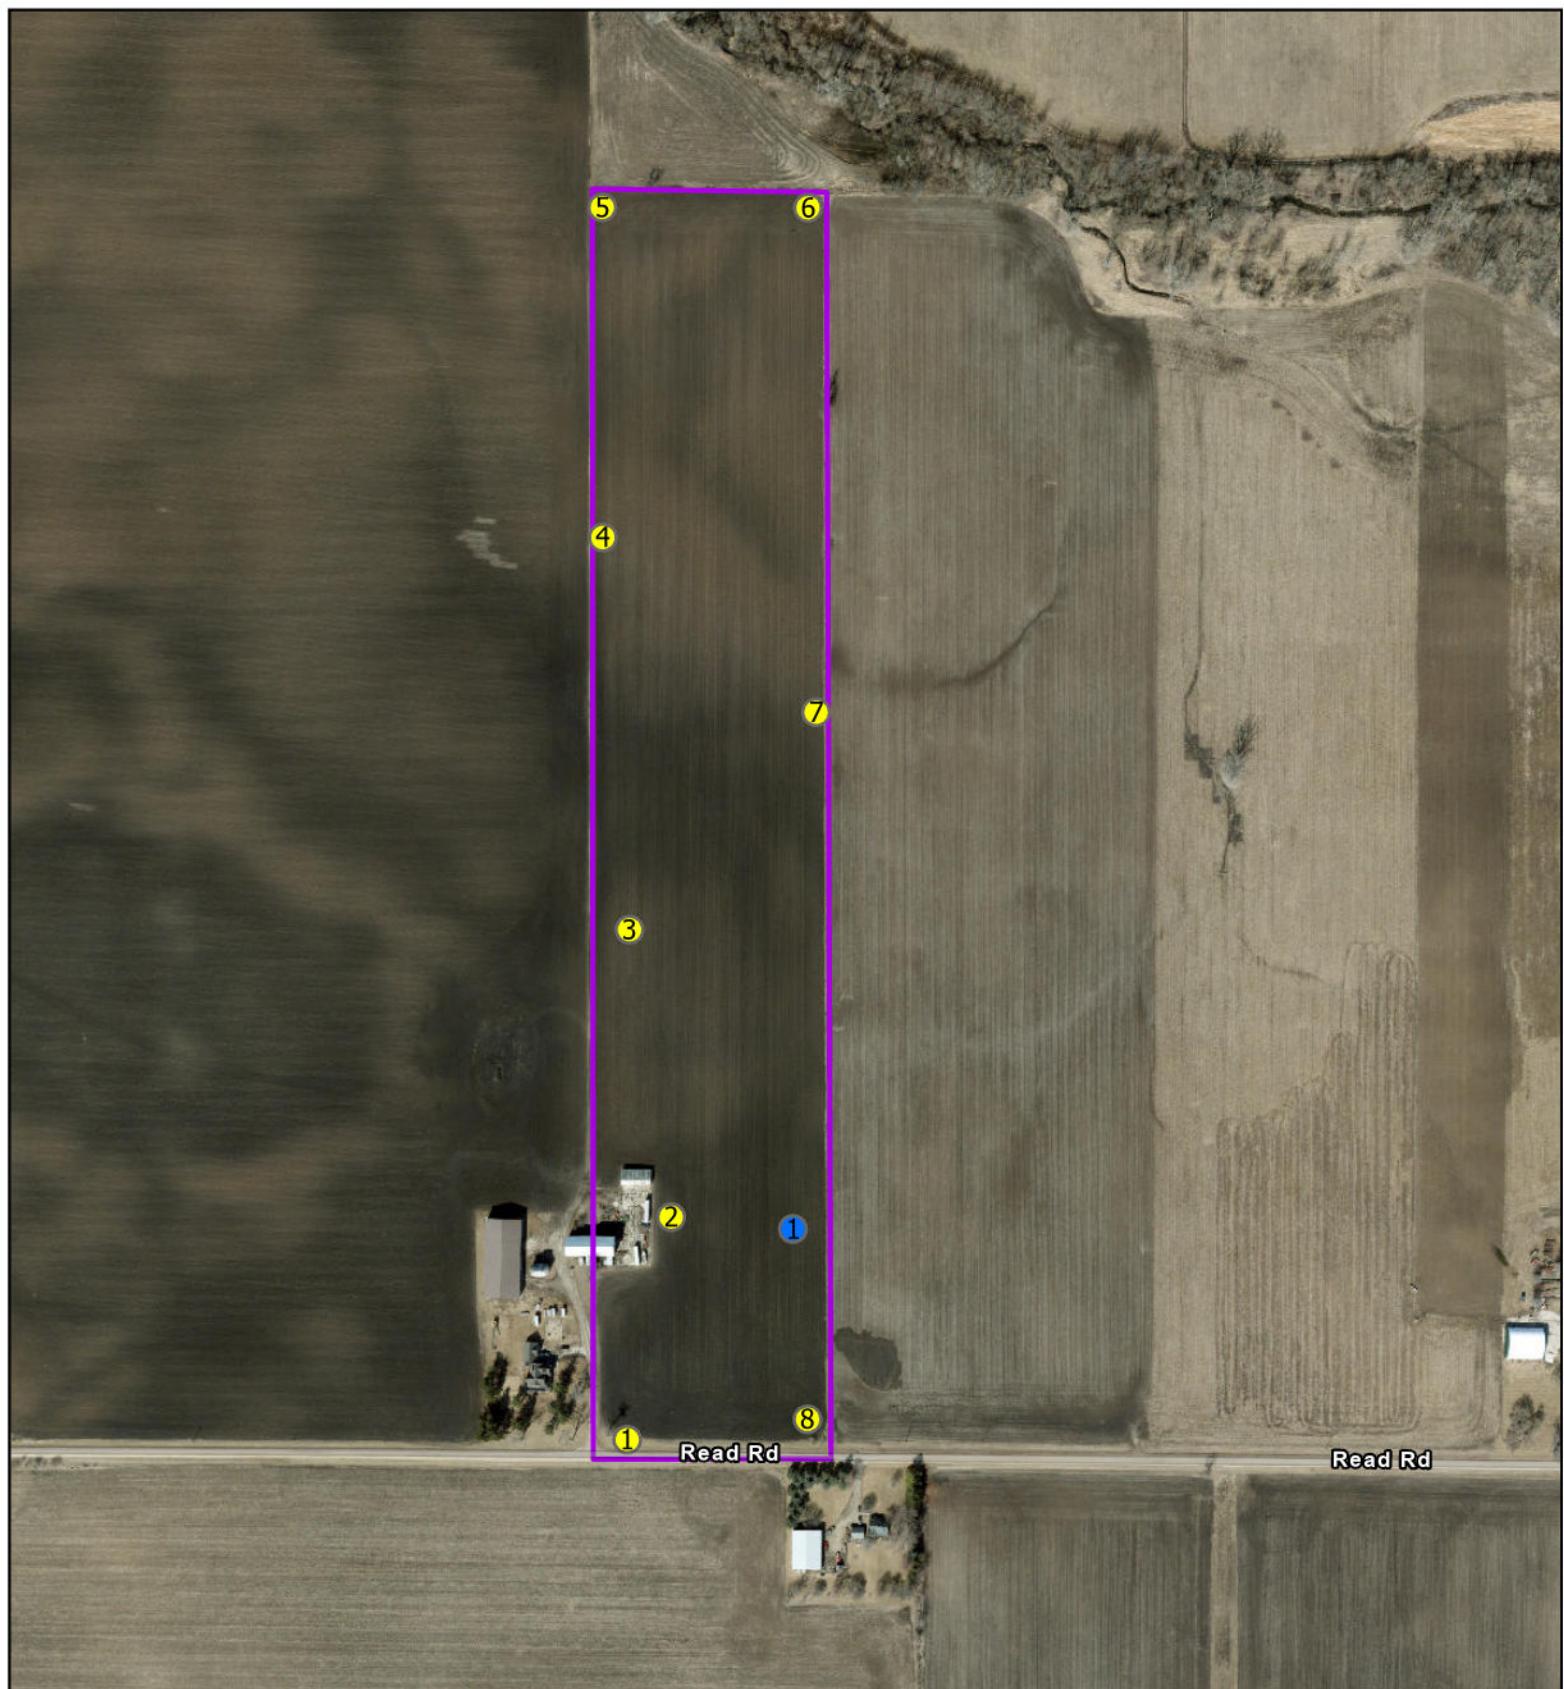
No portion of the study area met the criteria for wetland classification, as indicators of wetland hydrology, hydric soils, and hydrophytic vegetation were absent. A soil pit was excavated in the southeastern portion of the study area (Figure 1). Although the soil pit is located within the mapped hydric soil unit, no hydric soil indicators were present, nor was hydrophytic vegetation present (see attached data sheets).

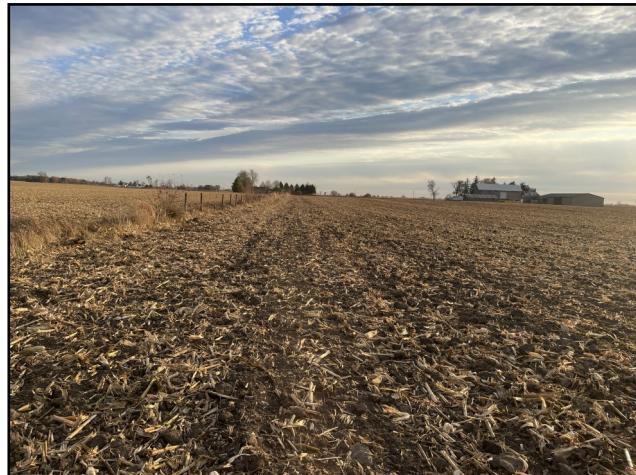
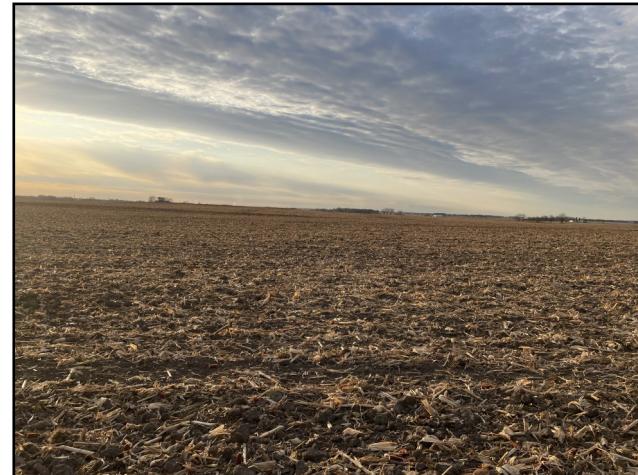
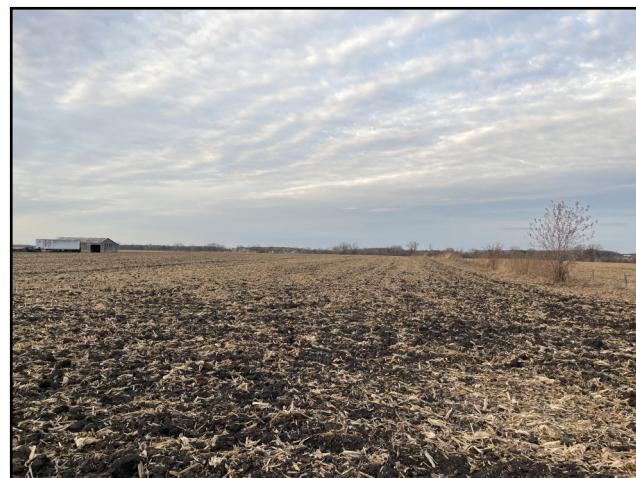
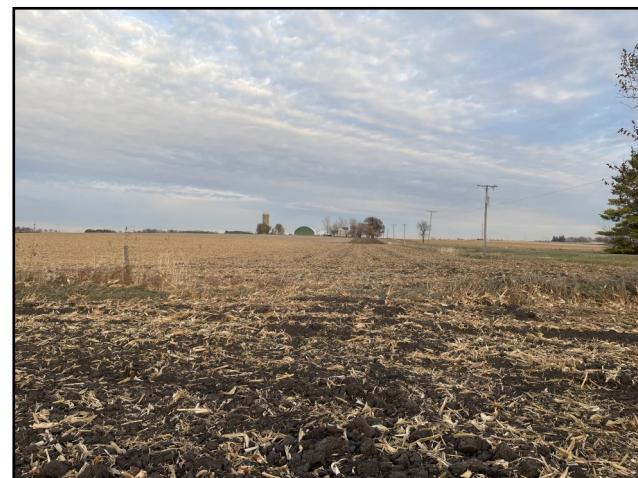
Data point 1, facing north

Depth (inches)	Matrix		Redox Features					Remarks
	Color (moist)	%	Color (moist)	%	Type ¹	Loc ²	Texture	
0 - 16	10YR 2/1	100					Loam	
16 - 20	10YR 4/1	98					Silty Clay Loam	
16 - 20	10YR 2/1	2					Silty Clay Loam	
-								
-								
-								
-								
-								
-								
-								
-								
-
