# **Wetland Delineation Report**

## **Tim Meyer – Ground-Mounted Solar Farm**

**Elgin Township, Kane County, Illinois**

**Project No. 25-0180**

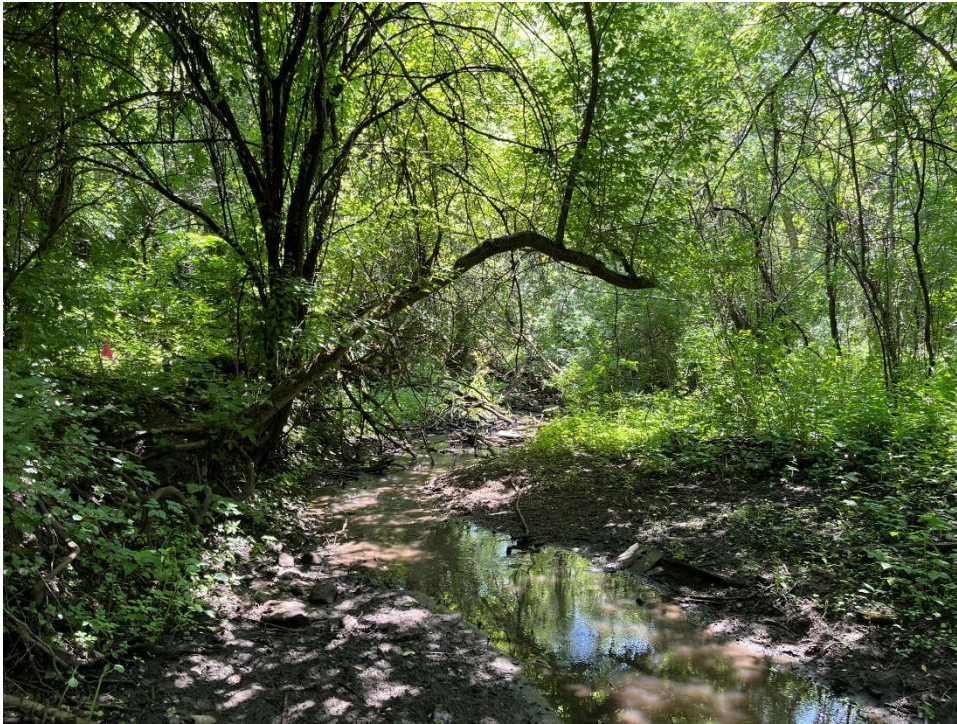
Photograph 1:

Typical view of Tyler Creek (Waters 1) channel at the south end of project site.

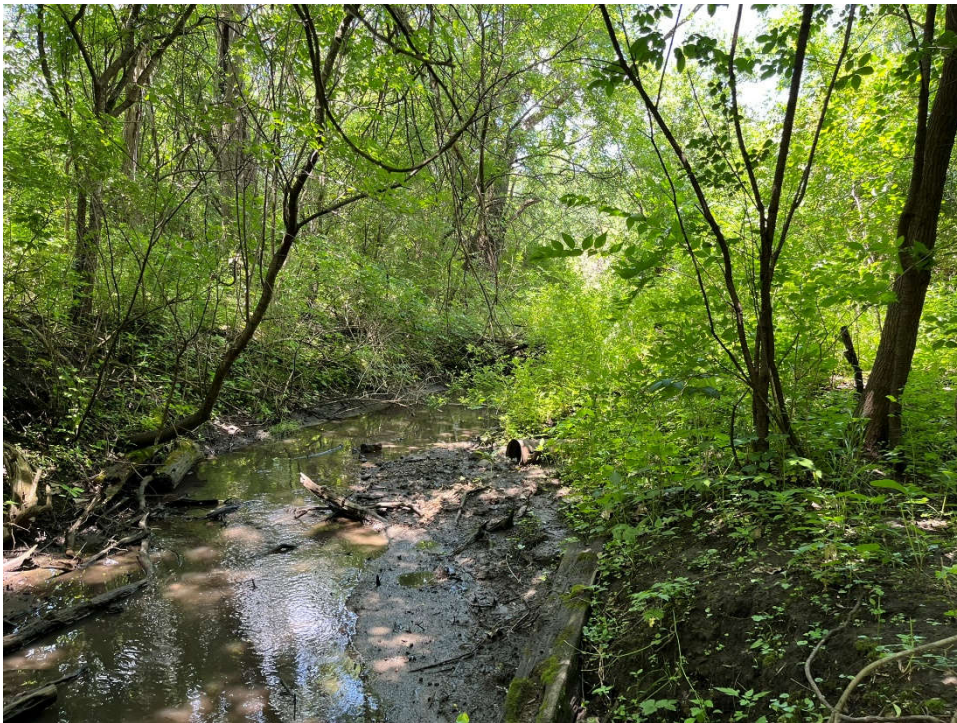
Photograph 2:

Typical view of Tyler Creek (Waters 1) channel along the south border of project site.

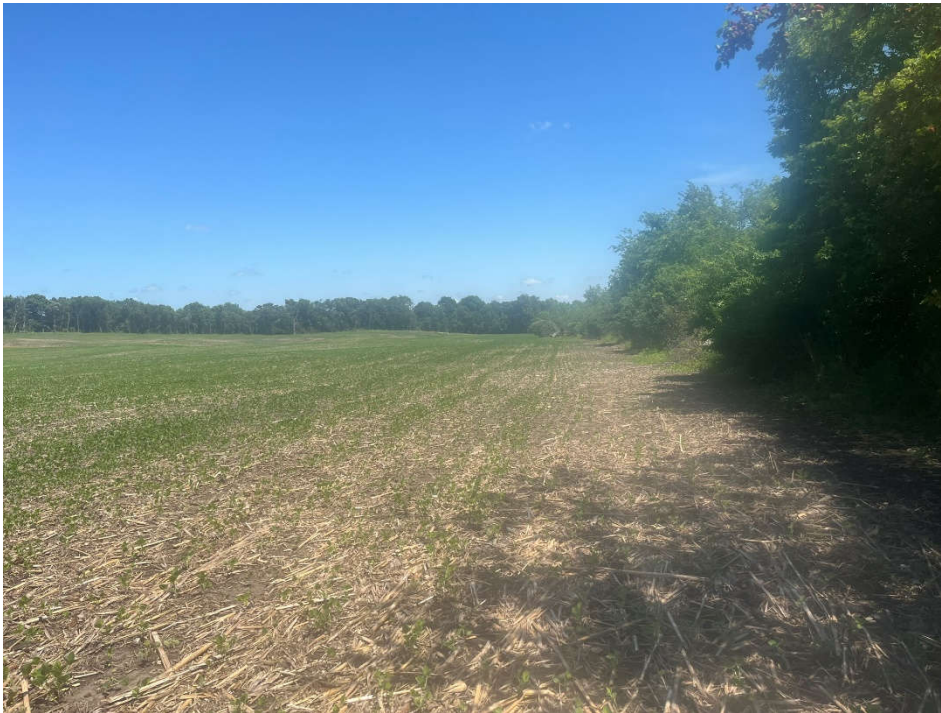
Photograph 3:

View east along edge of Waters 1  
near southern project site border.

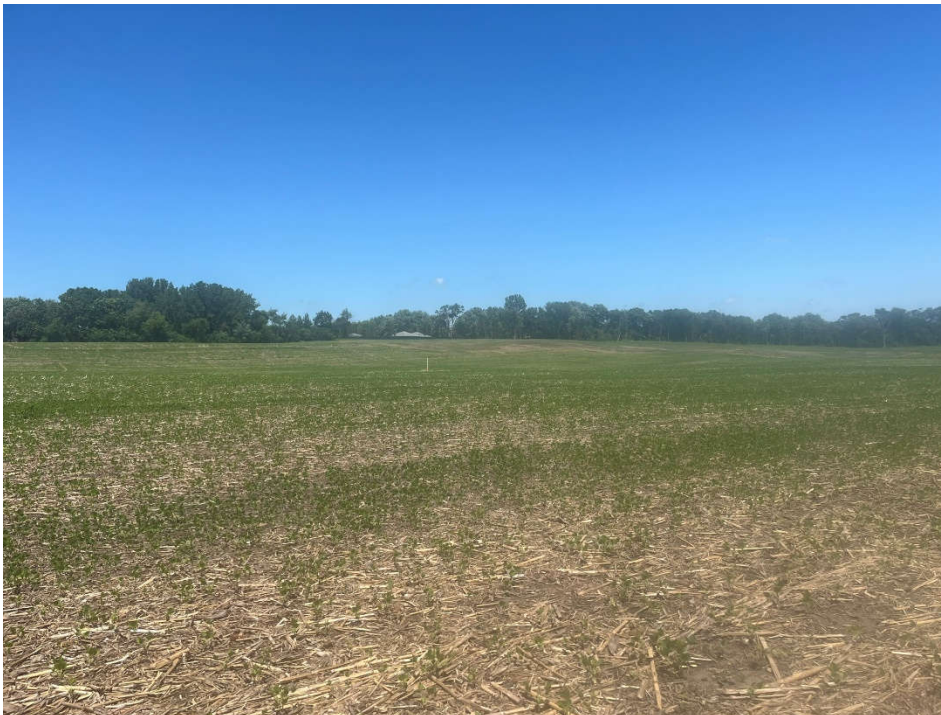
Photograph 4:

For the area designated as PFW2, three drain tile lines were installed through the area before 1984, including a 12-inch cement tile, an 8-inch cement tile, and some 4-inch clay tile laterals. These drain tiles were partially damaged which caused leaks in the lowest area. The 12-inch tile comes from the subdivision to the east, and they were responsible for repairing the damaged drain tiles. Mr. Meyer purchased the farm and went ahead and repaired these drain tiles to their prior function a few years ago. PFW2 was not evident during the 2025 wetland delineation inspection, and thus due to maintenance of the drain tile system it is not a farmed wetland.

View northeast across site and  
across area of Potential Farmed  
Wetland 2.

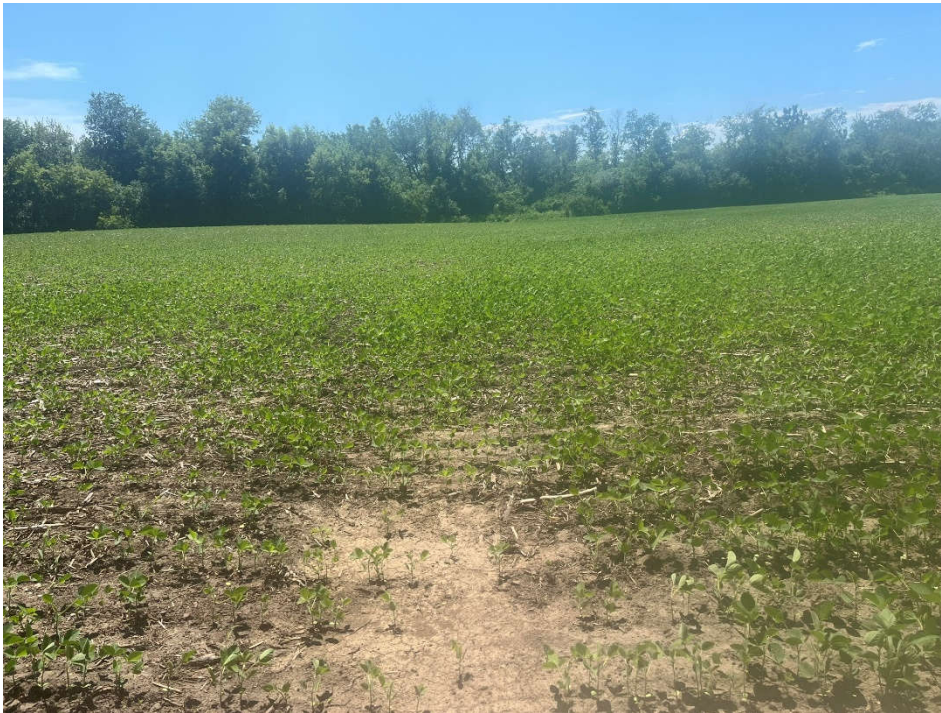
Photograph 5:

However, there is a 6-inch drain tile running through the bottom of the drainage path designated as PFW1 with a small basin on the northeast end (offsite) to catch water coming from the subdivision tile. The tile outlet passes through the trees along the creek bank. The design for the adjacent subdivision specified 40 feet of non-perforated tile from the creek bed to avoid the tree roots. The first spring after installation of this 40-foot tile, the tree roots plugged the tile and the water from the subdivision ran over the ground, affecting crop growth. The developer of the adjacent subdivision came out in the fall and replaced the tile with non-perforated pipe. The next summer the tile plugged again. The property owner (Tim Meyer) purchased a pipe camera and scoped the drain pipe and noticed a tree root had entered between the connection of two 20-foot non-perforated pipe sections. It is standard

practice to tape seams in rooted areas, and the tilers apparently did not do that. Mr. Meyer used a roto-rooter type machine and cleared the root structure from the pipe. Then rather than digging it up and taping the seam, he inserted two solid 4-inch pipes (seam taped) into the 6-inch pipe to prevent future roots from plugging the line. Therefore, this year (2025) there is no water or crop damage, as verified during our wetland delineation site inspection. Thus, due to repair and maintenance of the pass-through drain tile, this area is not a farmed wetland.

View south toward location  
Potential Farmed Wetland 1.

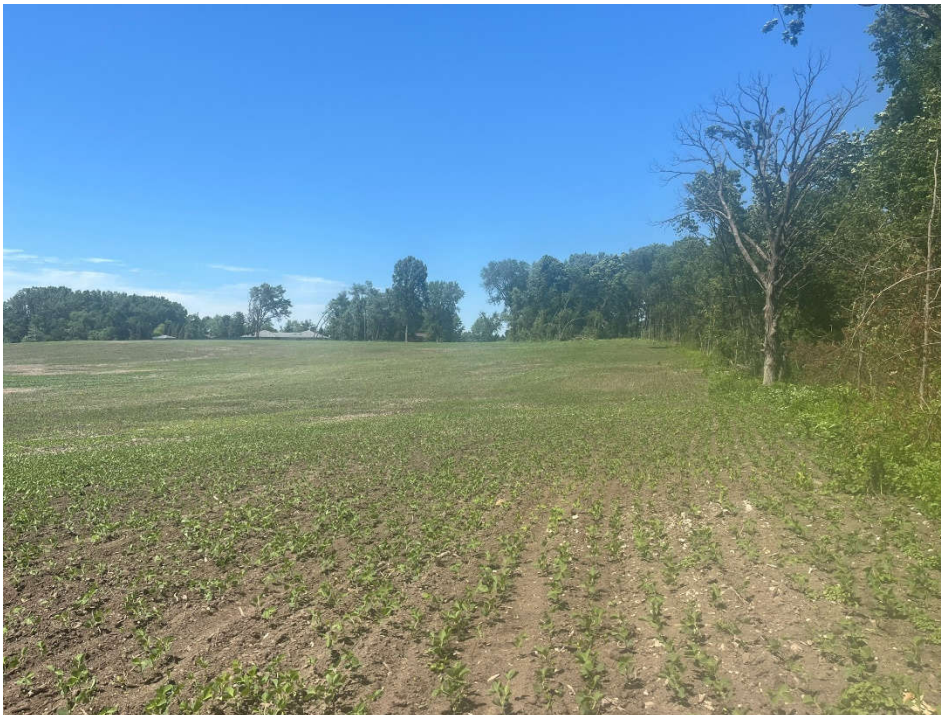
Photograph 6:

It should also be noted that the woodland that shows in all of the historic aerials in the northeast corner of the property, and was partially mapped as ADID wetland, has been cleared and is now a soybean field. It is a high point topographically within the site, and the ADID mapping is erroneous. It is not and was not likely ever wetland due to its position on the landscape.

View north along the eastern  
project site border that was  
formerly wooded.
