EXISTING AGRICULTURAL DRAIN TILE INVESTIGATION PLAN

SUNTRUST SOLAR

Prepared for: SUNVEST SOLAR, LLC

Section no.23, Rutland Twp., Kane Co., IL

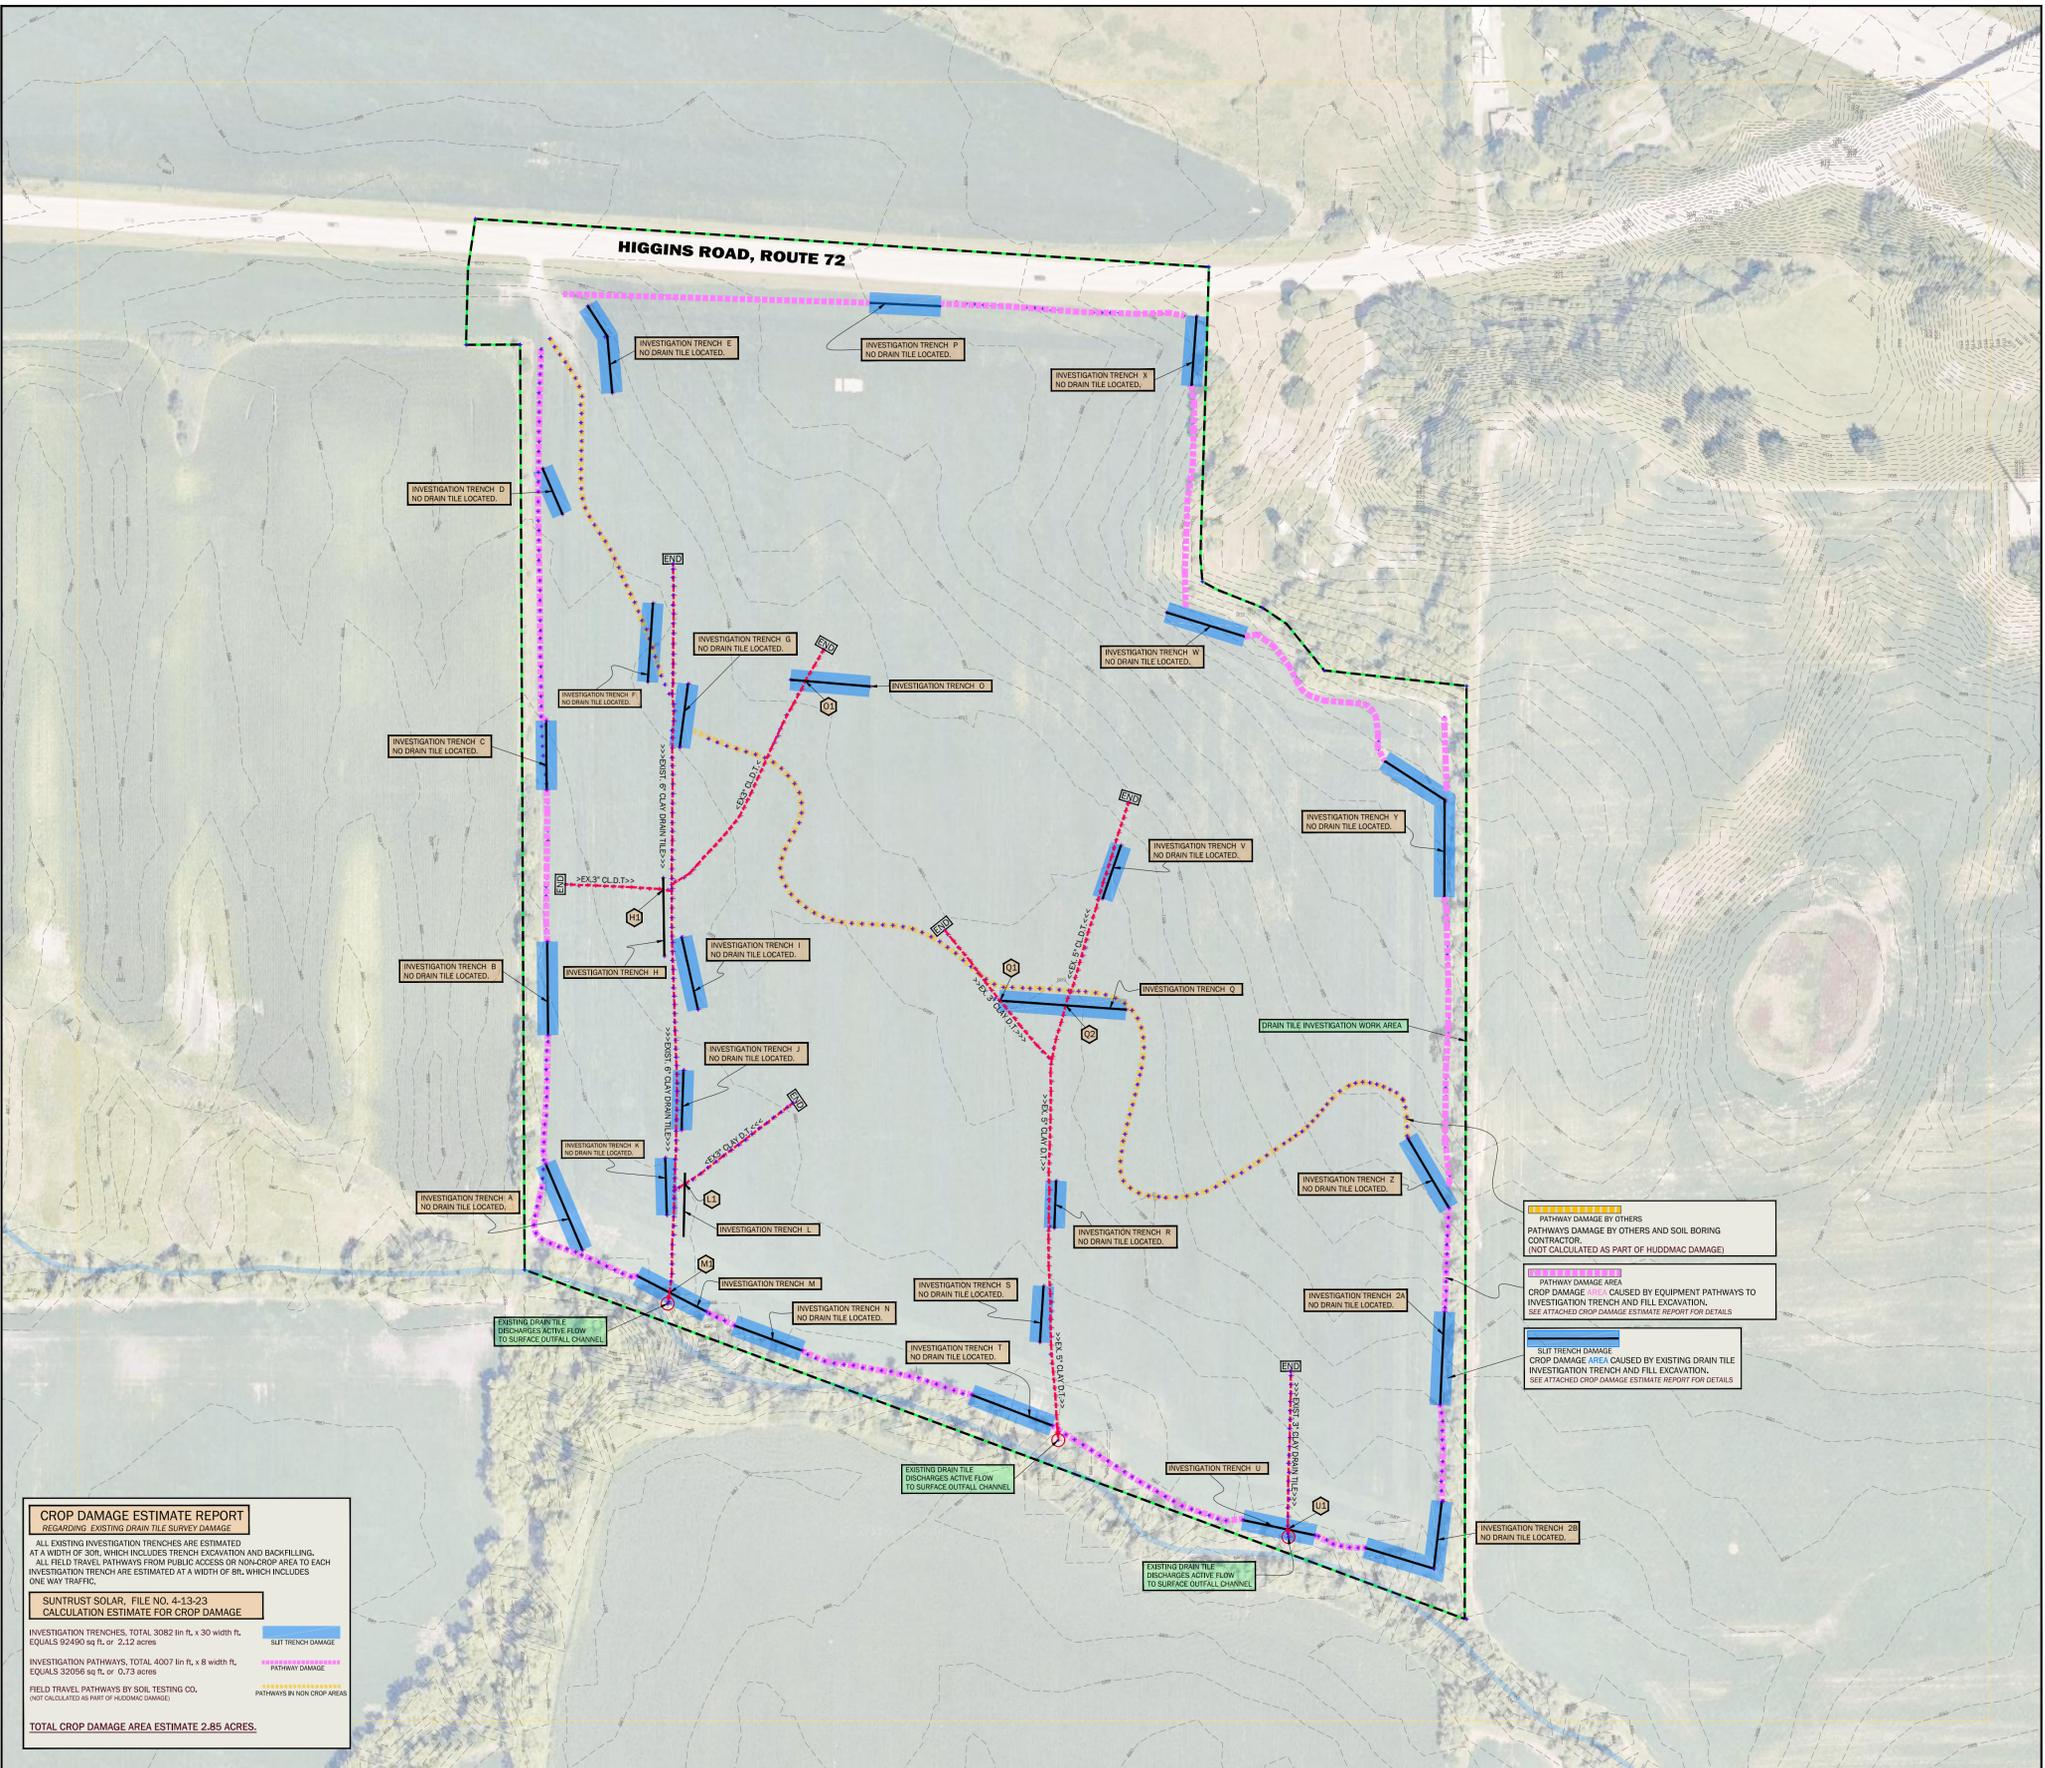
EXISTING SUBSURFACE AGRICULTURAL DRAIN TILE INVESTIGATION REPORT

SUNTRUST SOLAR / SUNVEST SOLAR, LLC, FIELD FILE NO. 4-13-23, DATE: 8/20/25.
IN ACCORDANCE WITH LOCAL COUNTY AND A.L.M.A. EXISTING DRAIN TILE INVESTIGATION & LOCATION STANDARDS
COPYRIGHT © 2025, BY HUDDLESTON MCBRIDE LAND DRAINAGE COMPANY
